| Revision 1 | <b>ALERT SERVICE BULLETIN<br/>No. 39</b> | DOA No.<br>EASA.21J.020 |

**Subject:** Replacement of the Propeller Guide Rod

**ALERT SERVICE BULLETIN  
No. 39**

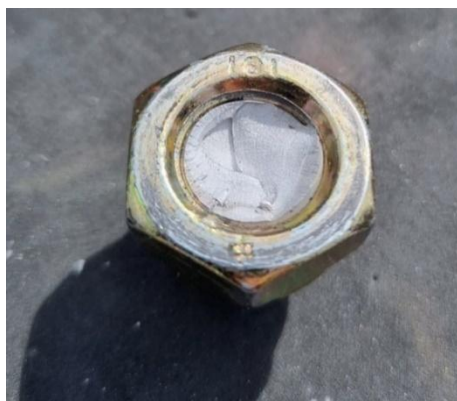
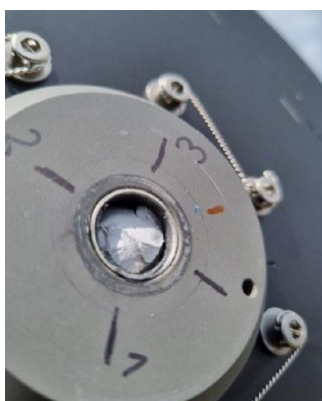
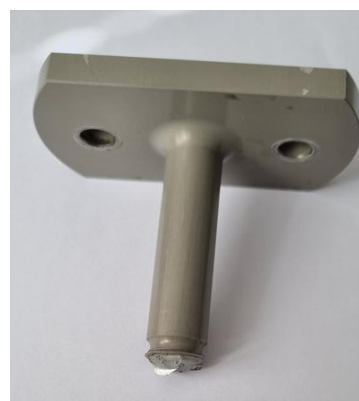
The originally installed propeller guide rod which is made out of aluminum (anodized colored) can be damaged when the propeller is used as a ground adjustable system.

Adjustments on the low pitch stop nut, can damage the aluminum propeller guide rod in the threaded area, when torqued with a high force to the stop.

Failure of the guide rod leads to a loss of thrust on the ground adjustable propellers.

**Action:** **THE ANODIZED COLORED GUIDE ROD MUST BE REPLACED WITHIN 6 MONTHS OR 100 FLYING HOURS, AFTER RELEASE OF THIS SERVICE BULLETIN.**

All mentioned propeller models, operated as ground adjustable units must have the stainless-steel guide rod (silver shiny) A-1856-1 (MTV-33 series) or A-1870-1 (MTV-34 series) or A-1931-1 (MTV-36 series) installed.

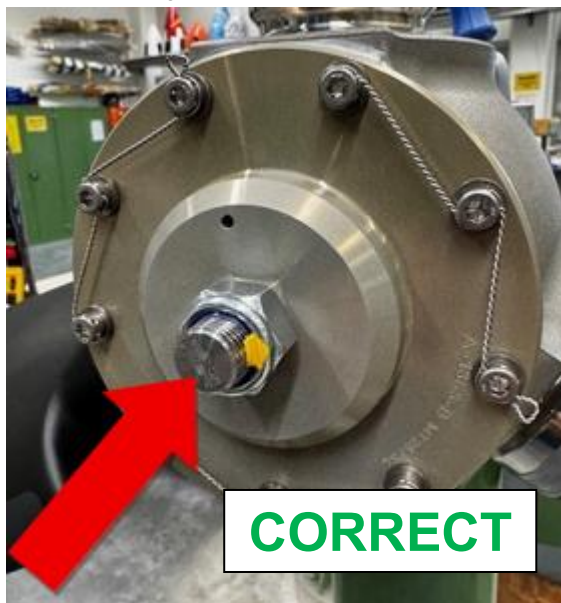
**Silver Shiny stainless steel** propeller guide rod A-1856-1, A-1870-1, A-1931-1 (see red mark below)

Not Affected

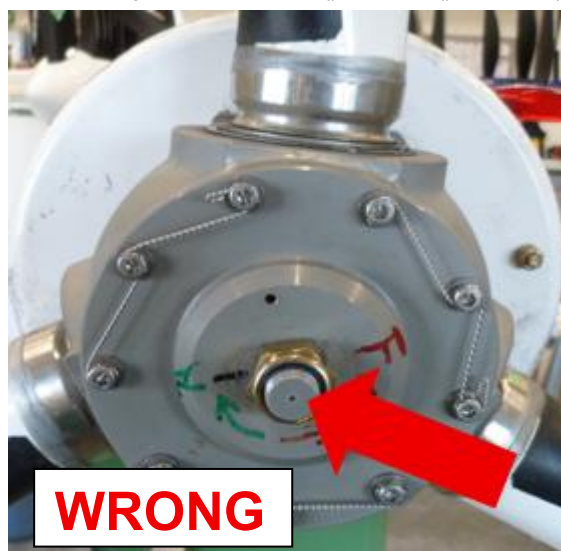
**The anodized colored** propeller guide rod A-1856-(), A-1870-(), A-1931-() (see red mark below)

Affected, if operated  
as ground adjustable  
propeller

For more information, please follow Overhaul Manual E-2286.
