| | <b>SERVICE BULLETIN<br/>No. 26 R5</b> | <b>DOA No.<br/>EASA.21J.020</b> |

**Subject:** a) **De-Ice Wiring on MTV-27-1 Propeller series  
With Dual - Element De-Icing Boots (3 wires)**

b) **Length of the spinner fixture screws**

**Affected Propeller:** **MTV-27-1 Propeller series equipped with dual - element boots (3 wires).**

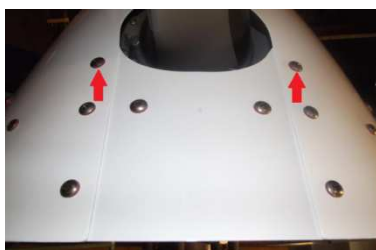
**Reason:** During operation a possible wear of the de-ice cable from the spinner bulk head to the connecting terminal on the blade counter weight clamp.

which fixing the filler plate on spinner dome between front and rear spinner bulkhead. The 10 spinner screws (see red marks on picture beside) C-306-8 should be replaced by the 10 spinner screws C-306-7 that they do not protrude the self locking nut which can wear out the de-ice cable.

The spinner screws C-306-9 (overall length 16,5 mm / 0,65 inch) should be replaced by the spinner screw type C-306-8 (overall length 15 mm / 0,59 inch) and spinner screw type C-306-7 (overall length 13,40 mm / 0,53 inch)

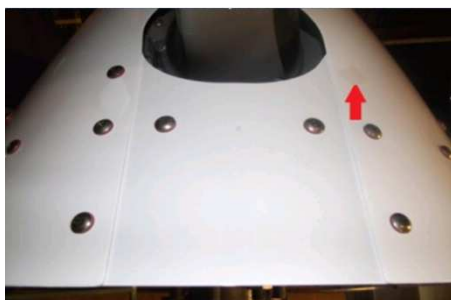
**Optional:** The spinner assembly comes without the spinner screw according the picture below.

**All the present spinner assemblies which are in service can be used without that spinner screw according the picture below.**

**Note:** In this case all the same spinner screw type C-306-8 can be used.
