| | <b>ALERT</b><br><b>SERVICE BULLETIN</b><br><b>No. 29 R2</b> | DOA No.<br>EASA.21J.020 |

**Subject:**                    **Splitted Retaining Ring Position Inspection  
which holds the blade in the propeller hub**

**Affected Propeller:**     MTV-33-1-A / ( ) - TCDS EASA-P.048  
MTV-34-1-A / ( ) - TCDS EASA P.049 ,  
**which are manufactured before June 2014.**

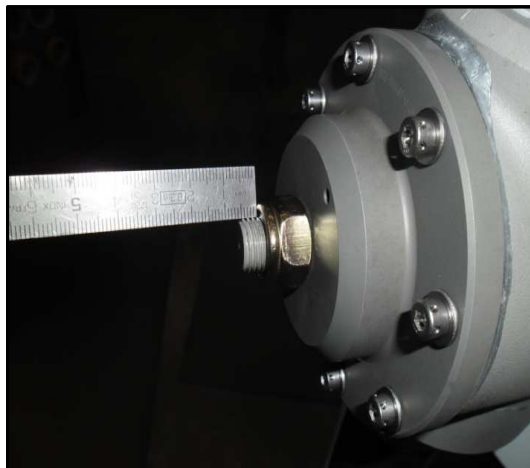
**Fig. 1**

Measure and notice the distance between stop nut M14 and front  
surface guide according Fig1.
3. Remove the front plate according Fig.2 by turning off the  
M14 stop nut.

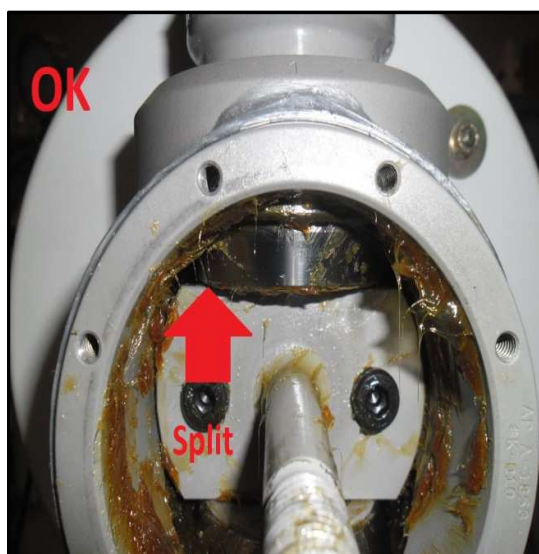
4. Check for correct split position according Fig.3a (OK),  
Fig.3b (incorrect)!

**Fig. 3a**  
Split line can be seen after removal of  
front plate and return spring at any  
position after removal of the front plate.

**If it is possible to identify and see the split line, assemble the propeller, no further action necessary.**

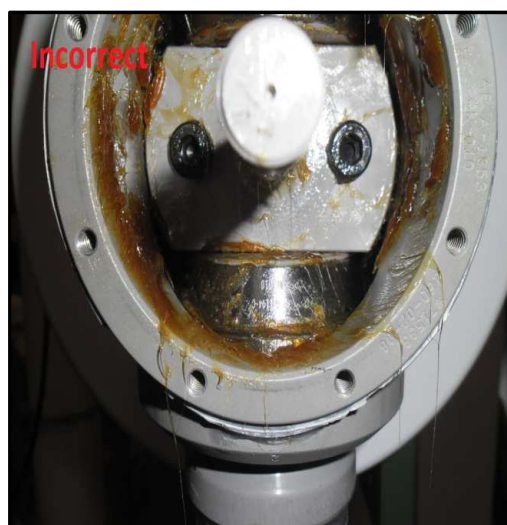
**If there is no accessibility to identify the split line (as shown on Fig.3b) please continue with Step 2.**

**Fig. 3b**  
Split line cannot be seen after removal of front  
plate and return spring.

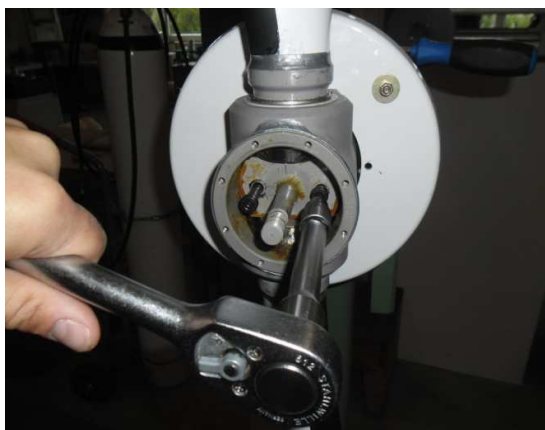
**Fig. 4**

5. Remove the guide rod according Fig.4 and Fig. 5 .  
Loosen M8 bolts, 2 screws for MTV-33 and 3 screws for MTV-34.
6. Turn the blade until the pitch change block and the pitch change pin is in front according the Fig.6 / Fig.7.

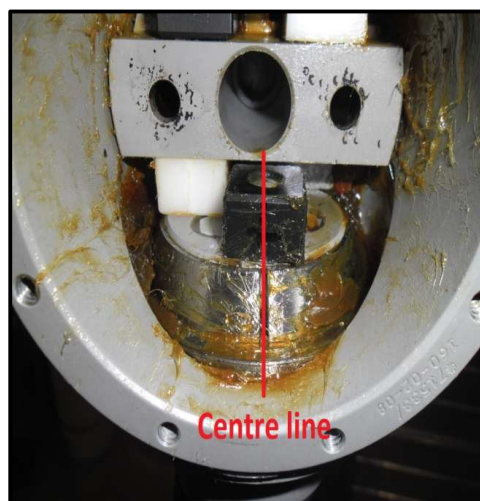
**Reason:**                    If the split line of the 2 piece retaining ring A-1194-( ) is at the pitch change pin position, a crack in the blade ferrule can occur resulting in excessive vibration.

**Fig. 7: Wrong!**  
Must be adjusted to position shown in Fig. 8!

7. Check for correct split line position.  
If the split line is directly in the centre line with the pitch change block and the pitch change pin (as shown on Fig.7), the propeller must be sent back to the manufacturer for repositioning.!
8. If the split line is more than +/-8mm (0,314 inch) from the pitch change pin (as shown on Fig.8), the splitted retaining ring is in correct position and the propeller can be assembled again.
9. Assemble the propeller in reverse order and secure them with safety wire.

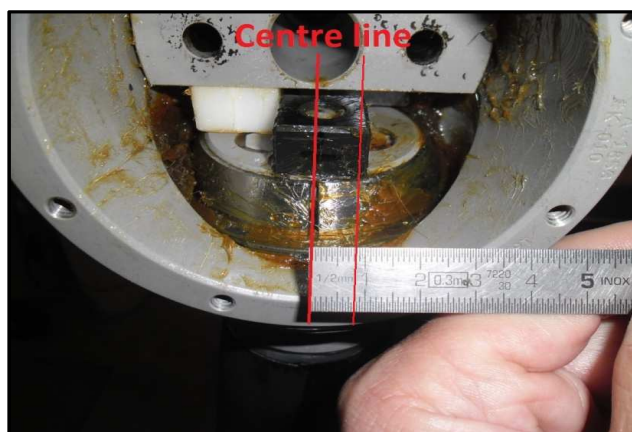
**Fig. 8: Correct !** Split line is min 8 mm (0,314 inch) from the pitch damage pin!
