## SERVICE BULLETIN

**No. 32**  
 - Initial Issue -

**Subject:** Replacement of Pitch Change Pins of Constant Speed Propellers

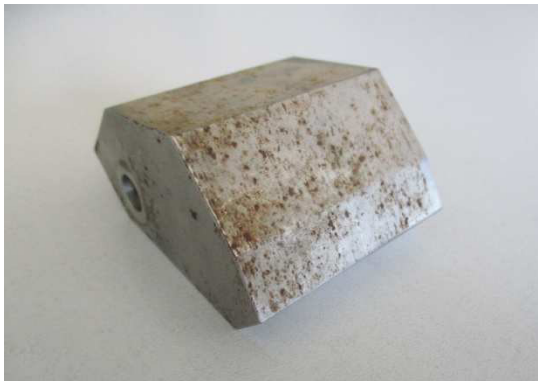
**Affected Propeller:** All constant speed propellers 12 years or older with noticeable corrosion on steel parts like counterweight bodies, counterweight modules or screws (examples see Figure 1 & Figure 2).  
 In case the pin or the blade ferrule has already been replaced, again every 12 years in case of noticeable corrosion. Markings for the traceability are shown in this Service Bulletin and in the Composite Blade Overhaul Manual E-1290.

The following pictures show examples of heavy corrosion on a counterweight module, counterweight body and screws.

**Figure 1: Corrosion on counterweight module**

**Action:** The pitch change pins must be replaced after disassembly of the propeller according to the procedures described in the Composite Blade Overhaul Manual E-1290. The replacement of the pitch change pins must be marked in the blade ferrule as shown in Figure 5.  
 If corrosion can be seen in the bore for the pitch change pin in the blade ferrule as shown in Figure 4 then the blade ferrule must be replaced as well. The replacement of the blade ferrule is described in the Composite Blade Overhaul Manual E-1290 and must be marked in the same way as shown in Figure 5.

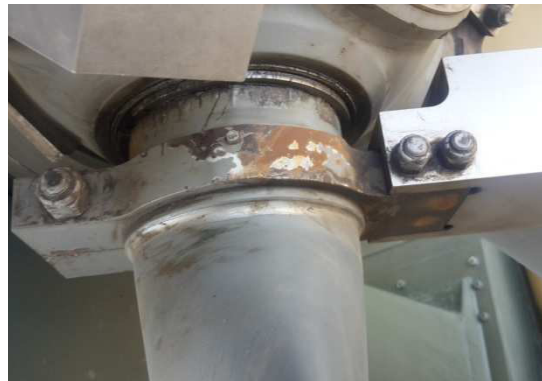
**Figure 2: Corrosion on counterweight body and screws**

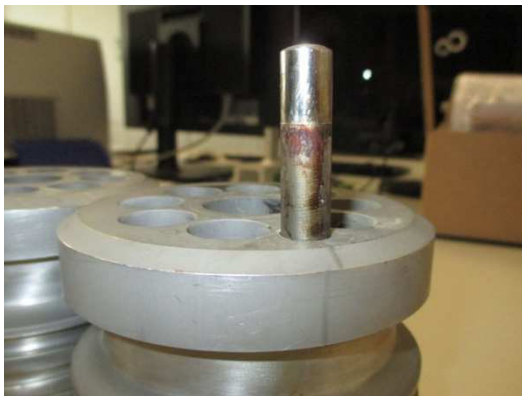
**Reason:** Corrosion was found on a pitch change pin of a constant speed propeller

The following pictures show corrosion on the blade pitch change pin and in the bore for the pitch change pin in the blade ferrule:

**Figure 3: Corrosion on pitch change pin**

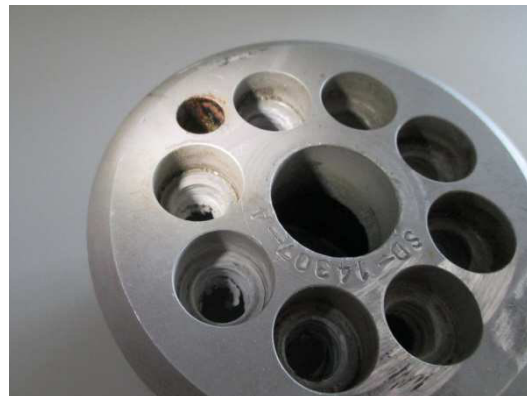
**Figure 4: Corrosion in blade ferrule bore for pitch change pin**

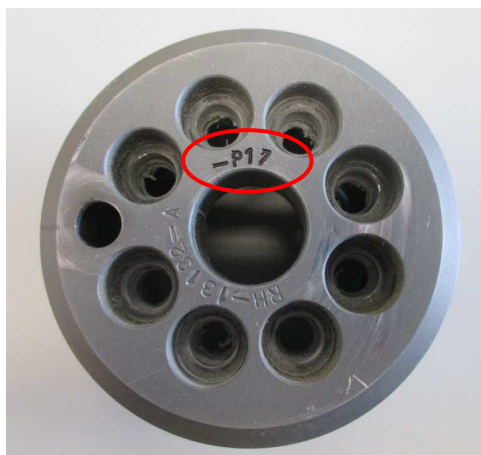
**Figure 5: Blade ferrule marked with “-P17” for replacement of the pitch change pin in the year 2017**

The replacement of the pitch change pin shall be marked on the blade ferrule for traceability. Therefore in case the pitch change pin is replaced the blade ferrule is marked with “-PXX” where XX represents the last two digits of the year in which the pin is replaced. For example is the pin replaced in the year 2017 then the blade ferrule is marked “-P17” as shown in Figure 7. When the pitch change pin is replaced together with the blade ferrule the blade ferrule is also marked with “-PXX”. Is the pitch change pin replaced a second time the blade ferrule again must be marked with the year of the replacement.
