| | <b>ALERT</b><br><b>SERVICE BULLETIN</b><br><b>No. 33</b> | DOA No.<br>EASA.21J.020 |

**Subject:** Replacement of the Blade Bearing A-1540 during Overhaul

**Affected Propeller:** MTV-9-B-S / 198-58B installed on Cessna 182/ Socata TB20 with  
SMA SR305-230-01 Diesel engine

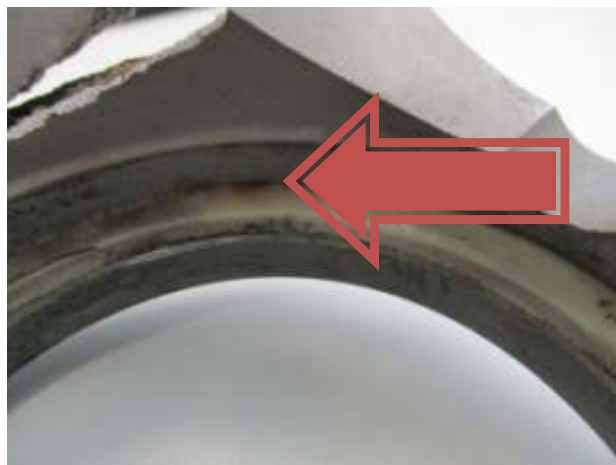
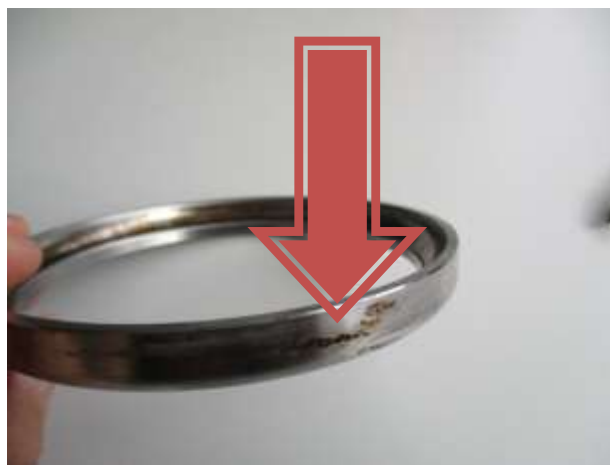
**Reason:** Excessive worn blade bearing races will cause the loss of the blade preload causing the bearing to move and damaging the hub. Contact friction signs can be found on the bearing race and propeller hub (see picture below).

**Action:** The blade bearing A-1540 **MUST be replaced** by a new blade bearing if signs of wear are found.

1. Degrease inside the propeller hub the blade bearing seat with MEK or similar.
2. Degrease blade bearing race with MEK or similar.
3. Glue in blade bearing races with Hysol Epoxy Patch 0151( NO GREASE ON THE HUB SIDE ).
4. Remove excessive Epoxy and install curing fixture Tool T-171.
5. After 24 hours of curing at 21°C (70° F) or 3 hours in a oven at 60° – 80°C (140°F-176° F) remove fixture and clean bearing race surface with MEK or similar.

**Important: No blade tip play is allowed**
