| | <b>SERVICE BULLETIN</b><br><b>No. 38</b><br>- Revision 0 - | DOA No.<br>EASA.21J.020 |

**Subject:** MT-Propeller Hub inspection

**To:** All Owners / Operators of MT-Propeller MTV-27-1-E-C-F-R(G)/CFRL240-55d which are installed on Mitsubishi MU-2B- ( ).

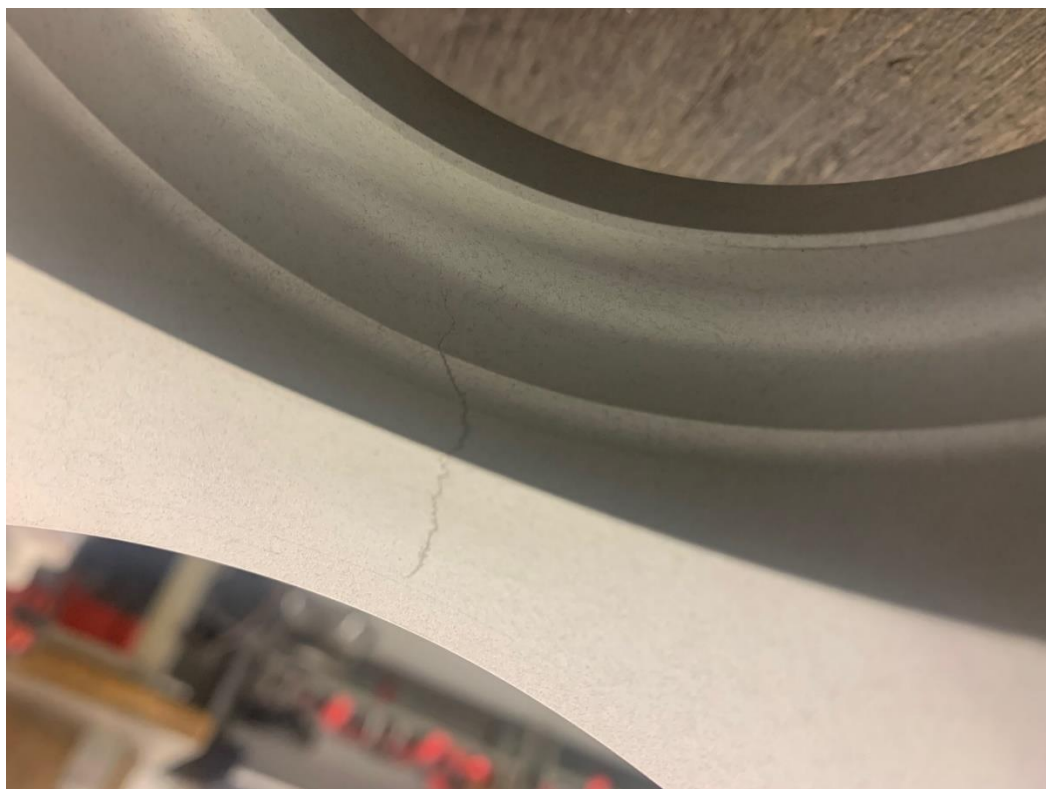
**Reason:** During a regular propeller overhaul on the above-mentioned installation, the start of crack propagation on the inner side of the hub between front plate and plate bearing has been detected.  
Following an intensive material analysis, it is most likely, that the reason for crack initialization is caused by inappropriate etching during hub overhaul. An additional vibration test focusing on the cracked area also supports this analysis.  
In worst case, this crack propagation could, if not identified early enough, lead to a blade separation and therefore further in field experience shall be gained.

The crack has been found inside the hub on the smallest material thickness between the front plate and the blade bearing. The pictures below shall provide more precise description of the detected crack.

This picture shows the detected crack on the inner part of the hub. The blade bearing is located on the upper part, the front plate is mounted on the lower left part of the picture.

1. If any indications are detected during visual inspection or dye penetration testing:
  - a. Immediately remove the propeller from service.
  - b. Fill the data required on the Compliance Form, supplement it with a detailed photo documentation and send it to MT-Propeller Techsupport ([techsupport@mt-propeller.com](mailto:techsupport@mt-propeller.com)).

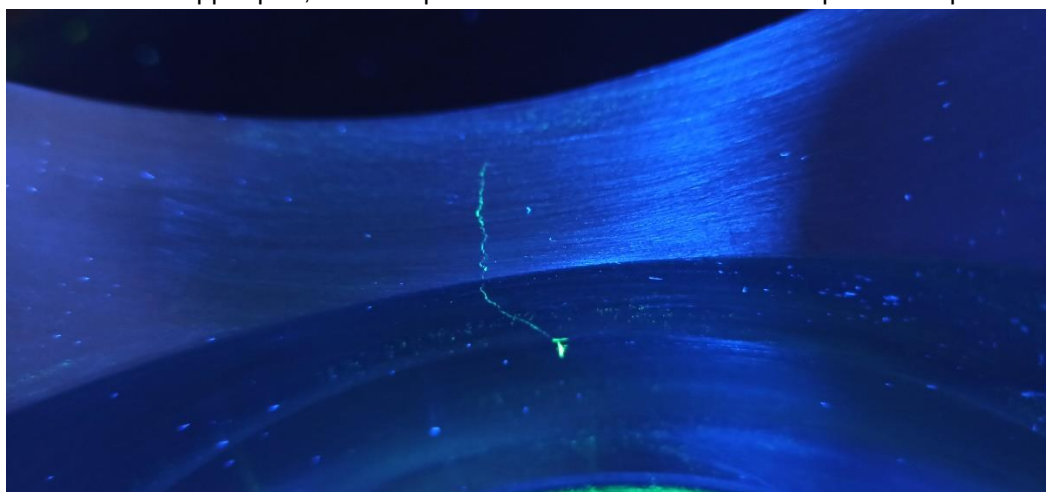
The crack gets clearly visible by dye penetration testing. The blade bearing is located on the lower part of the picture and the front plate is mounted on the upper part of the picture.

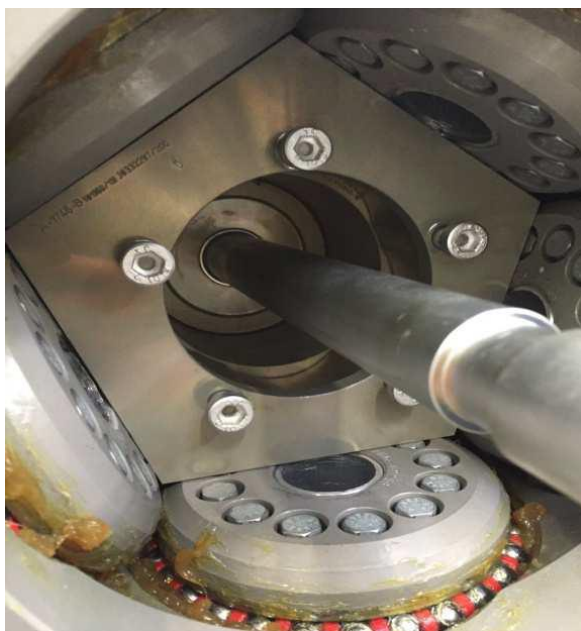
This picture shows the inner part of the hub after deinstalling the front plate and the springs. Do not further disassemble the pitch change mechanism or blades!

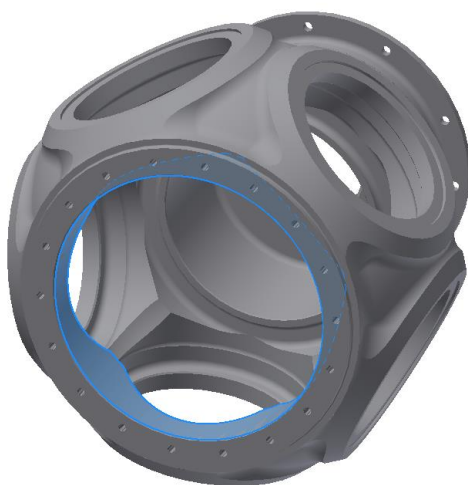
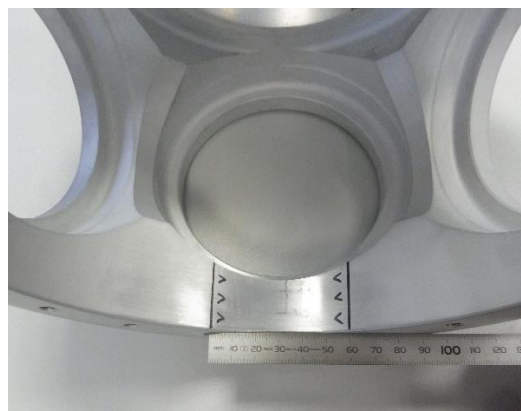
Inspection area is located between +/- 30 mm (1.2 inch) on each side of the narrowest material (between the two black lines).

2. Clean the above marked area with industrial cleaner or brake disc cleaner, do not allow cleaner to enter the blade bearings inside.
3. Visually inspect the marked area with a 10x lens and a bright flashlight for any signs of cracks. Special focus shall be taken on the inner corner of the described area. Report any signs of cracks on the Compliance Form and send it to MT-Propeller Techsupport. In case of any crack detection, continue with Eddy Current inspection (details available from MT-Propeller).

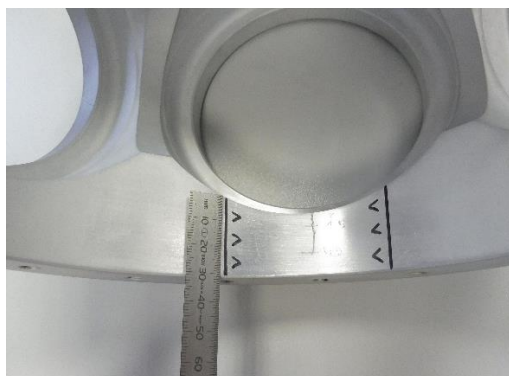
The surface which is smaller than 30 mm (1.2 inch) must be inspected (inside the black lines).

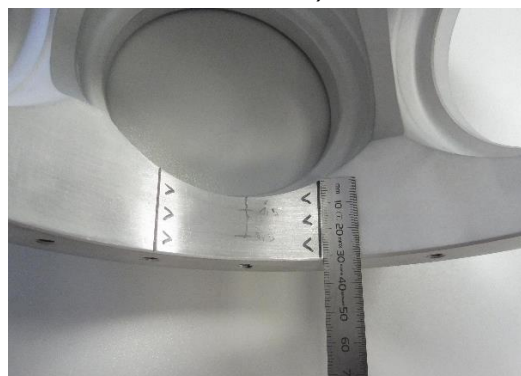
The surface which is smaller than 30 mm (1.2 inch) must be inspected (inside the black lines).
