| | <b>Service Letter<br/>SL 31A</b> | DOA - No.<br>EASA.21J.020 |

MTV-9-B-S/198-58B

Rework and Modification of Blade Preload Nut A-1368 and Blade Ferrule A-1367

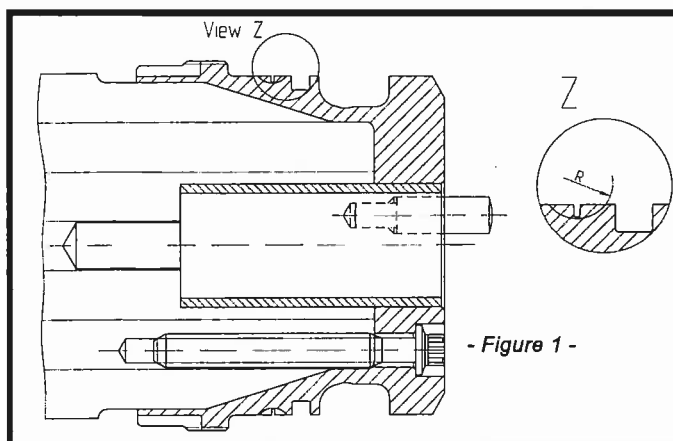
During operation the pre-load / bearing washer C-235 can wear into the Blade Ferrule A-1367.

The Blade Ferrule can be reworked according to this Service Letter in the affected area according to Figure 1.

Clamp the complete blade at the Blade Ferrule into the lathe (maximum 150 rpm).

Rework the worn area with a radius tool (radius 3-5 mm / 0,12 - 0,20 inch)

until the sharp worn area is round. Remove not more material so that a minimum diameter of 103,5 mm (4,07 inch) is still existing. After rework treat the area with Alodine.

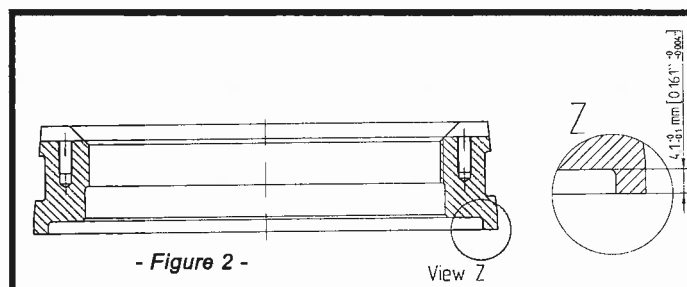
The Preload Nut A-1368 must be reworked before assembly that the outer O-ring has lower friction. The dimension in Figure 2 should be maximum 4,1 mm (0,161 inch).

Clamp the blade pre-load nut into a lathe and rework the nut until a dimension of 4,1 mm (0,161 inch) is given. After rework re-anodize nut or put Alodine on affected area.
