| DOA - No.<br>EASA.21J.020 | <b>Service Letter<br/>SL 32-2</b> | Revision 1 |

**Performance of Minor Infield Repairs of the Natural Composite MT-Propeller Blades  
during the Operation Time Between Overhaul Periods**

All MT-; MTE- and MTV- Propellers with Natural Composite Blades

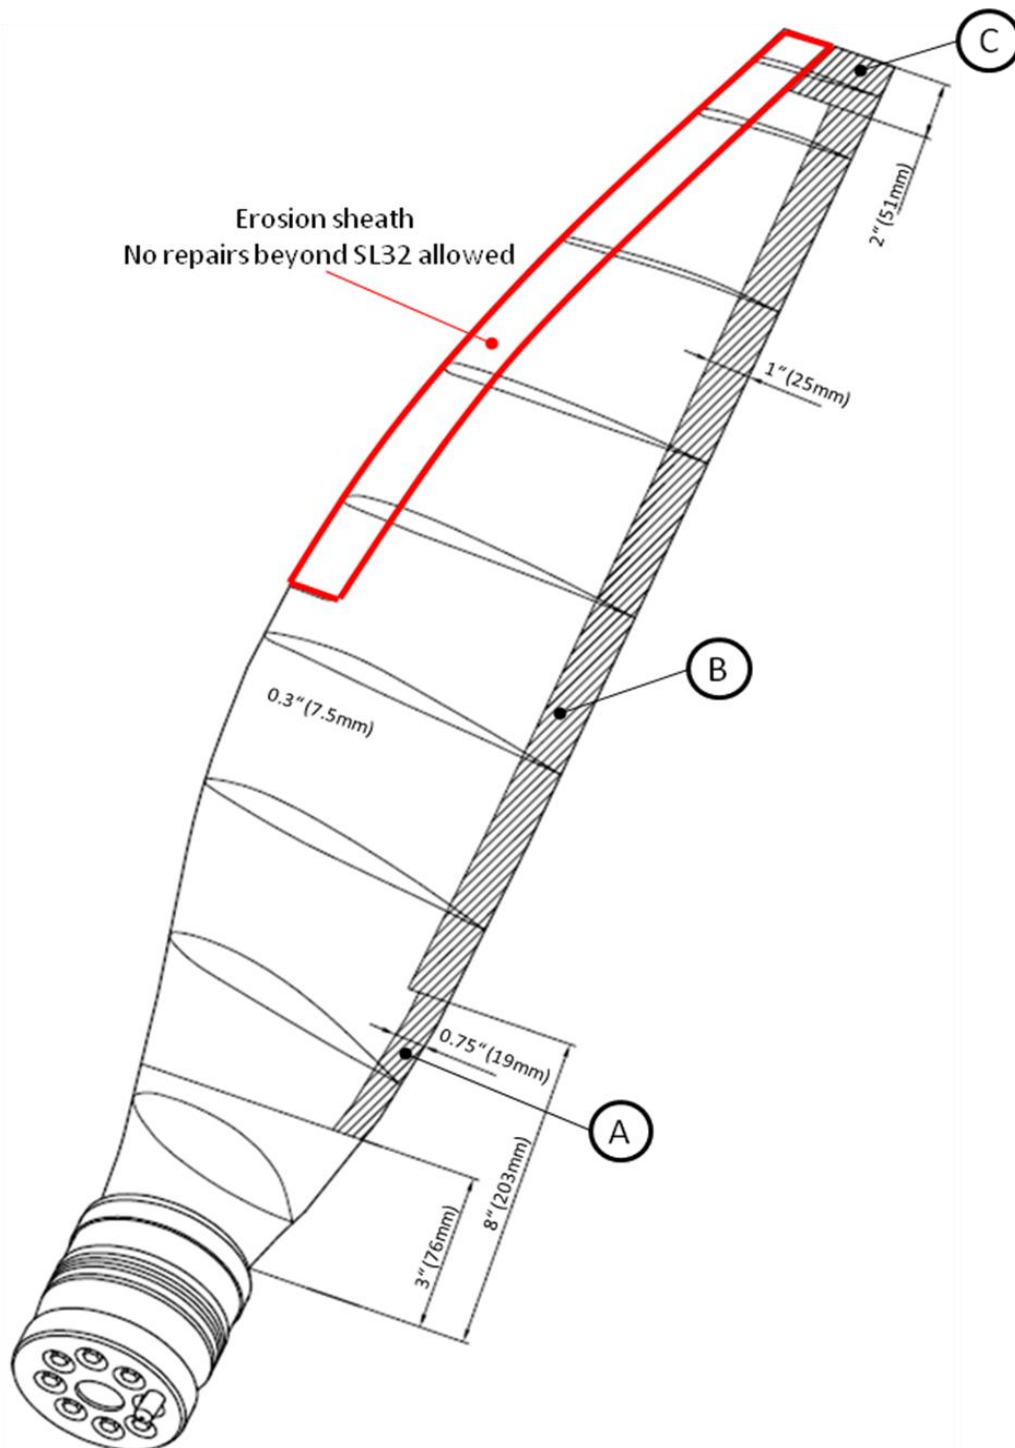
The extension of repair limits consists of three areas A to C which are shown in figure 1 and defined as follows:

- **Area A:**  
Parallel to the trailing edge, a width of 0.75 in (19mm), 3 in (76mm) to 8 in (203mm) from the blade ferrule
- **Area B:**  
Parallel to the trailing edge, a width of 1 in (25mm), 8 in (203mm) from the blade ferrule to the tip of the blade
- **Area C:**  
A width of 2 in (51mm) parallel to the blade tip, excluding the area of the erosion sheath.

This Service Letter 32-2 extends the damage dimension limitations from Service letter 32 parallel to the blade edge acc. to the areas A to C, see figure 1.

Figure 1: Areas of extended repairs performed by certified overhaul service centers
