| DOA - No.<br>EASA.21J.020 | <b>Service Letter<br/>SL 32</b> | Revision 9 |

## In-Field Repairs

All MT-; MTE- and MTV- Propellers with Natural Composite Blades!

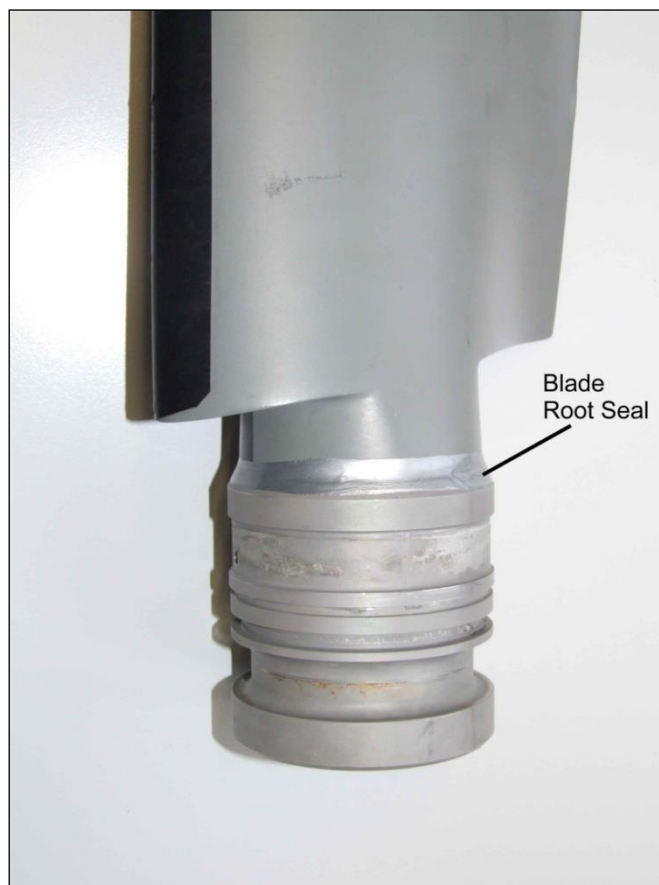
**Possible Damage:** Cuts due to incorrect spinner installation.

**Repair:** Clean the affected area and fill up the affected area with Silicone.  
(Refer to List of Materials)

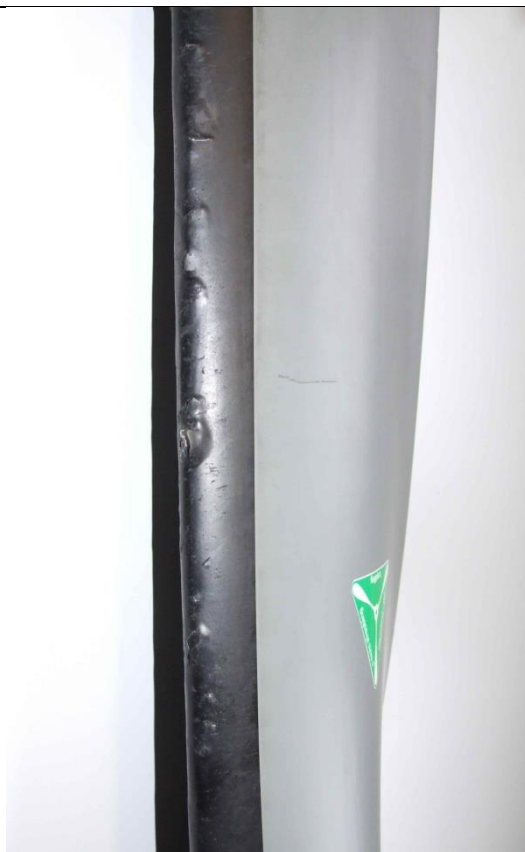
Typical Damage: Punched through PU-Strip

**Possible Damage:** Punched through or missing.

**Repair:** Completely replace erosion strip according to SI.37 ( )

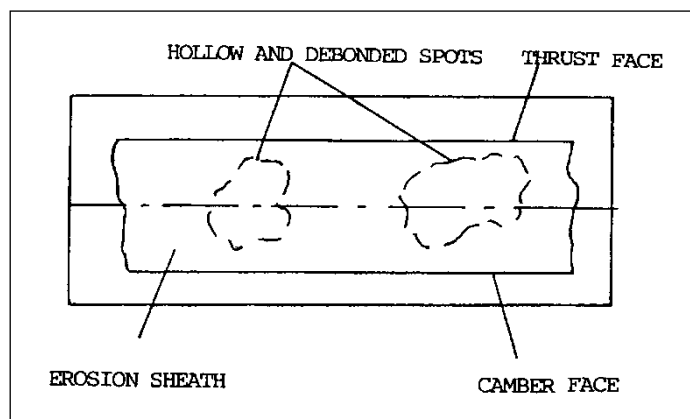
#### 2.3.1. Debonding and Delamination on Stainless Steel Edge:

In case of debonding only very limited repair is possible.

If any hollow and debonded spots exist, mark them.

Whenever performing pre-flight inspection, monitor whether there are further delamination and/or whether the already existing delamination has become worse.

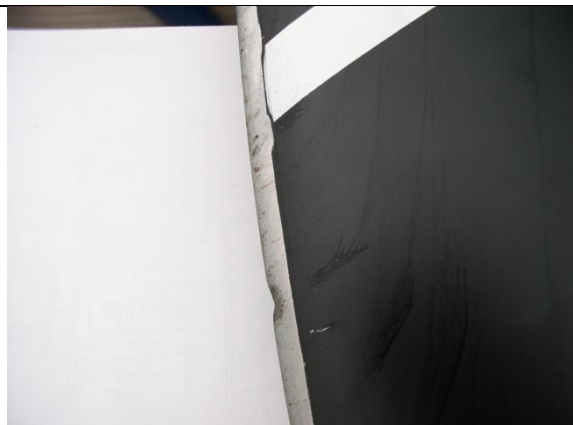
#### **FOD below 6 mm x 6 mm (0.24 in x 0.24 in):**

If within 51 mm (2 in) no other dents of that size are visible, the dent size may exceed the original maximum size by 3 mm (0.12 in) to a maximum of 9 mm x 9 mm (0.36 in x 0.36 in).  
If within 76 mm (3.0 in) no other dents of that size are visible, the dent size may exceed original maximum size by 5 mm (0.197 in) to a maximum of 11 mm x 11 mm (0.43 in x 0.43 in)

No action necessary if not delaminated.

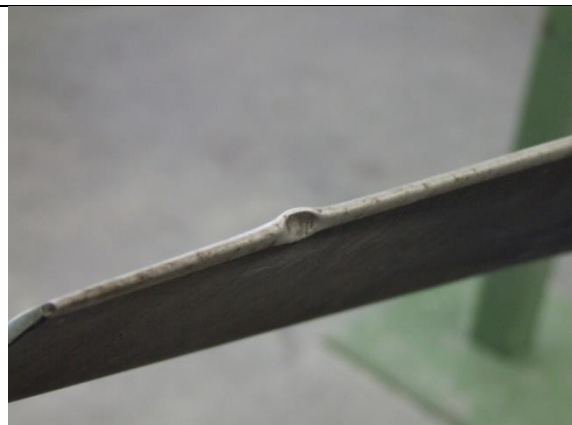
#### **FOD exceeding limits.**

Limits are determined on the left side.

Replace Erosion Sheath as soon as possible!

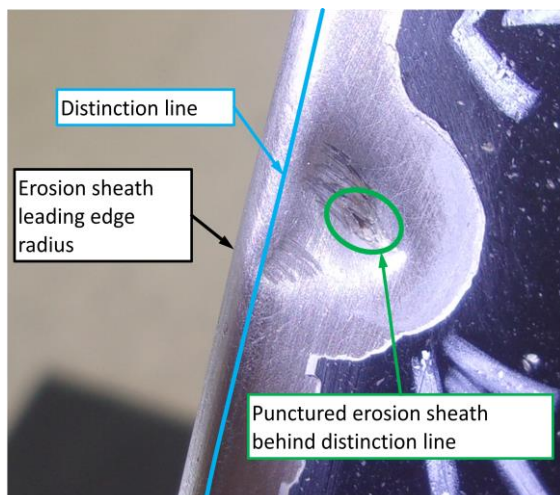
Damaged area can be filled with epoxy; erosion sheath will be replaced at next overhaul

- Fill with epoxy to prevent moisture intrusion
- Erosion sheath is replaced at next overhaul
- Monitor the area at pre-flight inspection

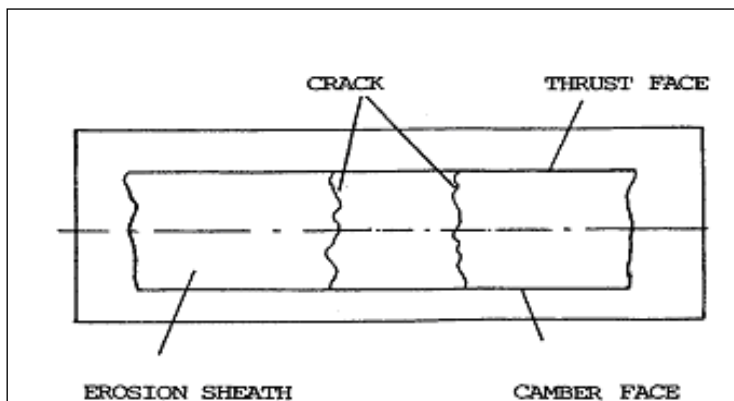
Chord wise cracks in the erosion sheath may also occur together with fine surface cracks indicating high vibration loads on the blade.

Cracked erosion sheaths require immediate repair. If chord wise cracks appear, return the propeller to the manufacturer or any authorized Service station.

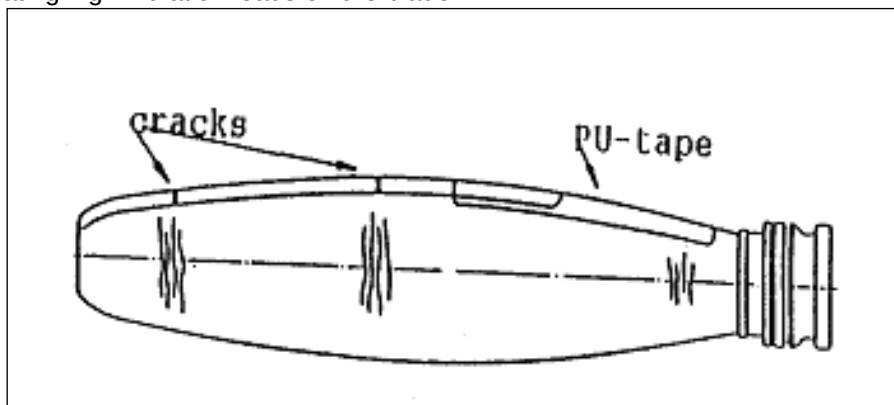
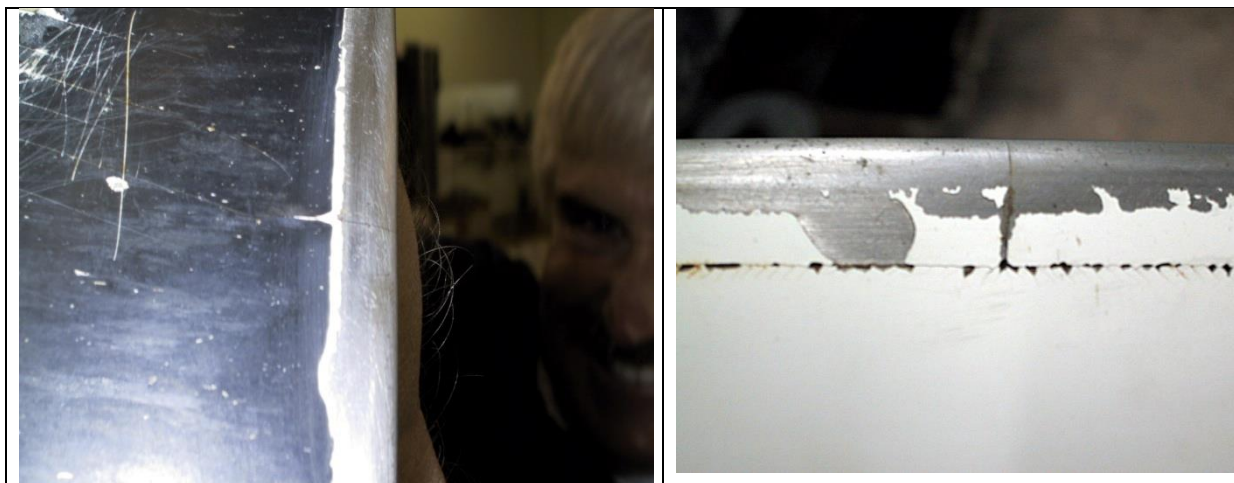
When Erosion Sheath is cracked chord wise no field repair is possible

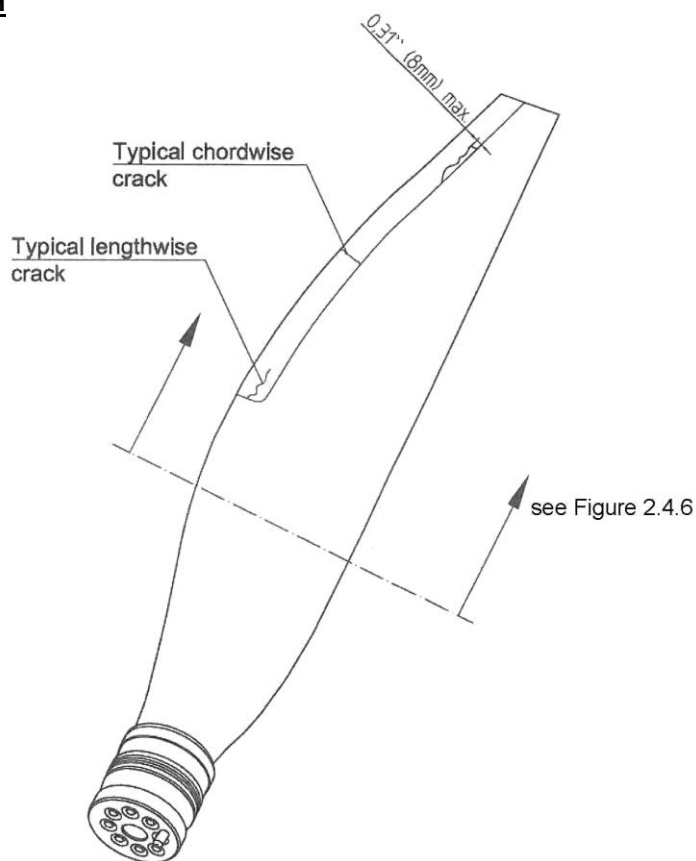
Figure 1: Missing portions of Nickel erosion shield (Trail side) and typical cracks

| <b><u>Airworthy damage limits:</u></b> | Two chordwise cracks are only allowed if they are not starting from the camber side to the thrust side and may not be within 152.5mm (6 in) of each other. A chordwise crack over 25 mm (1.0 in) may not be within 152 mm (6.0 in) of the blade tip. A chordwise crack over 25 mm (1.0 in) may not be within 152 mm (6.0 in) of the outboard end of the anti-icing boot. A chordwise crack over 25.5 mm (6 in) may not be within 152 mm (6.0 in) of the inboard end of the erosion shield (when not covered by anti-icing boot). Refer to Fig.1, 2 |

| <b><u>Airworthy damage limits:</u></b> | The maximum permitted length of a crack is 50 mm (2.0 in). Two lengthwise cracks may not be within the same linear length on the erosion sheath. This includes cracks on opposite sides of the blade. Refer to figure 1, 2, 4, 5. |

| <b><u>Minor repair limits:</u></b> | Minor repair is not authorized. If the crack is greater than the airworthy damage limits, an overhaul is required inclusive a leading edge replacement.<br><br><b><u>NOTE:</u></b><br>IN ANY CASE, SEAL THE CRACK WITH ANY 5 MINUTE METAL EPOXY OR SIMILAR TO AVOID MOISTURE ENTERING UNDERNEATH THE LEADING EDGE. |

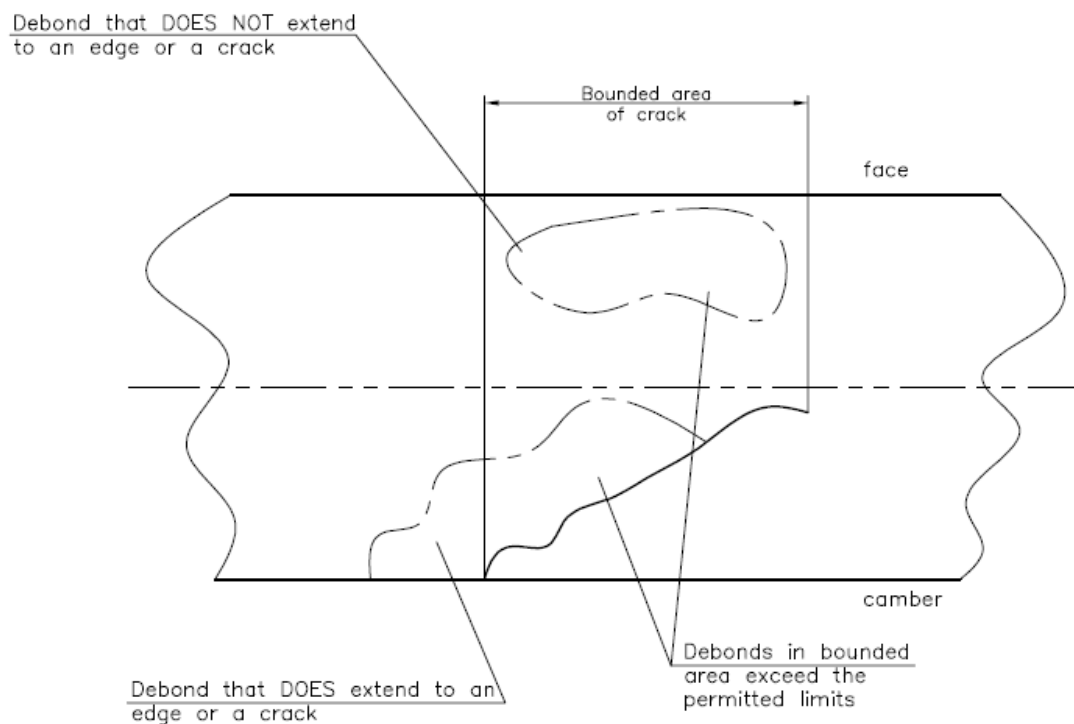
Fig.3 Debonds in excess of allowable limits

| <b><u>Airworthy damage limits:</u></b> | A maximum of 20 % of the erosion sheath may be debonded in any 152 mm (6.0 in) length of the erosion sheath<br>Refer to Figure 1, 3 |

| <b><u>Major repair limits:</u></b> | Major repair is not allowed. If the debond is greater than the airworthy damage limits and cannot be repaired under Minor Repair, an overhaul is required including leading edge replacement. |

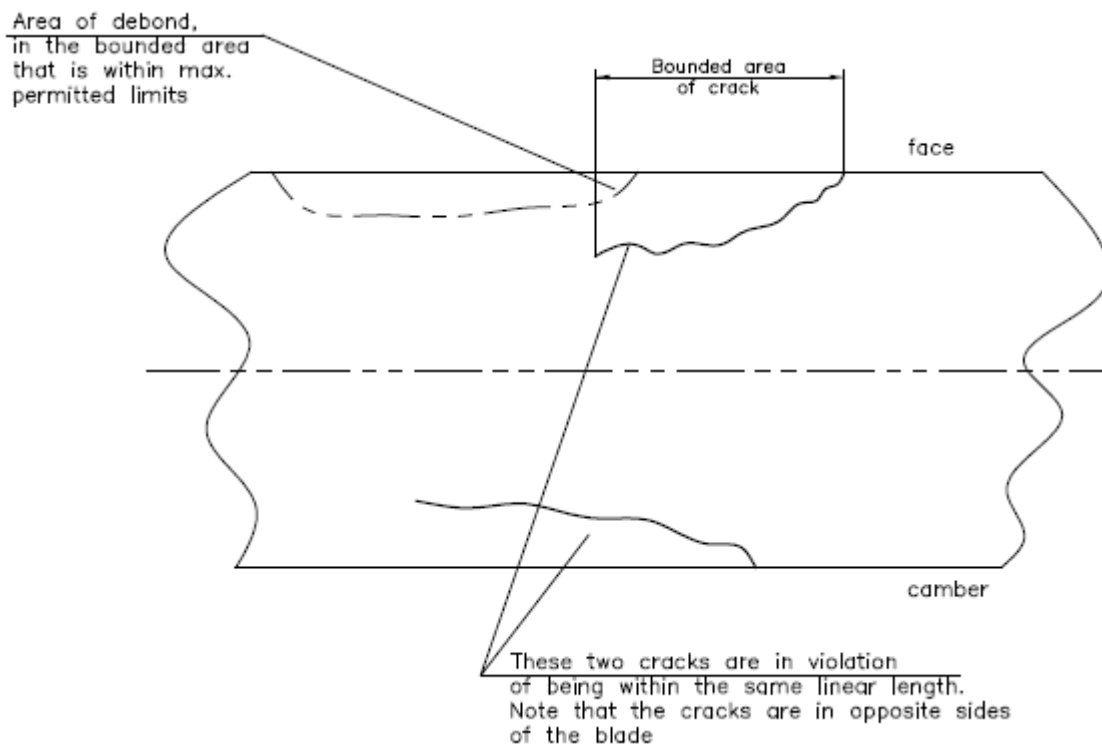
Figure 5: Acceptable Erosion Sheath Debond, non acceptable crack location

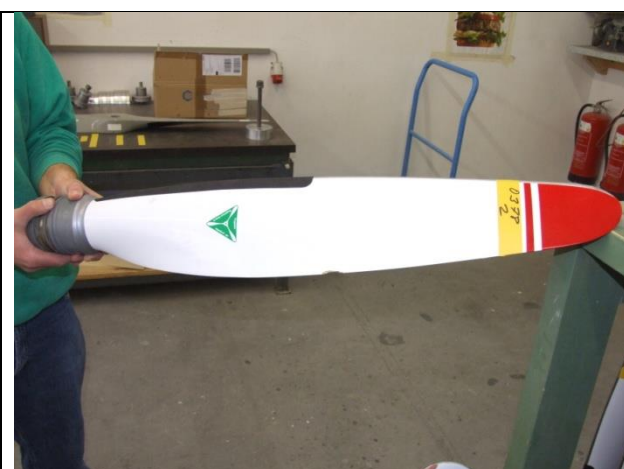
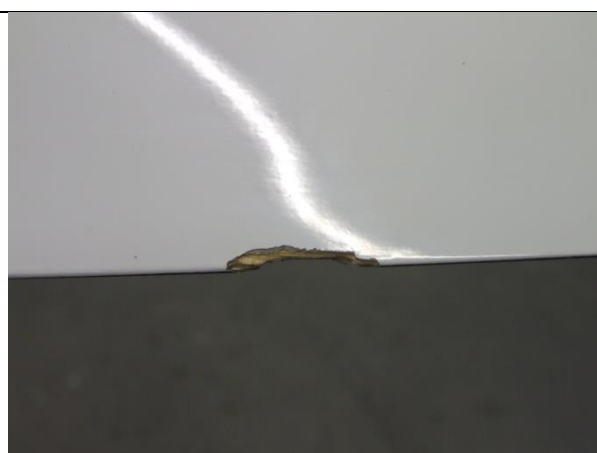
Tow bar damage, seal with Epoxy or repair permanently with fiber glass

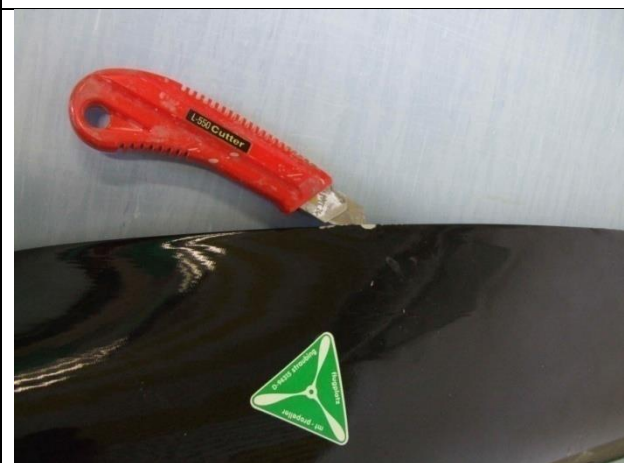
Delaminated composite shell on the trailing edge

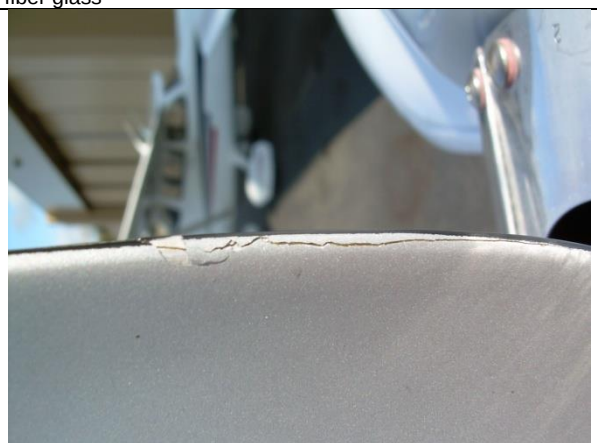
Damage caused by Cowling, seal and fill up with Epoxy

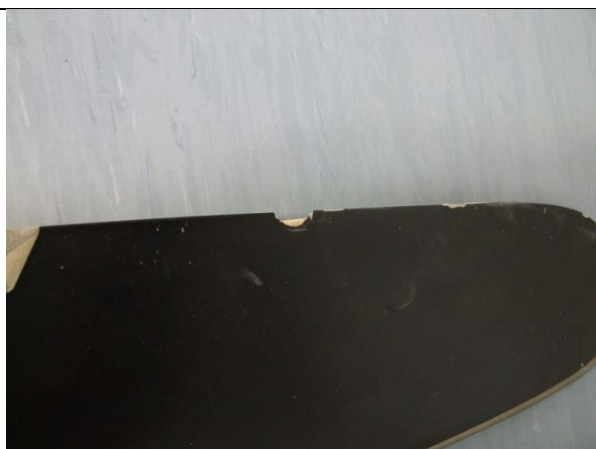
Minor damage on the trailing edges may be sealed with 5-Minute Epoxy

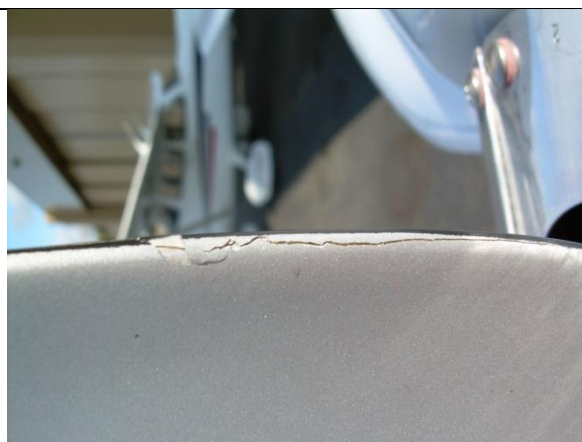
Longitudinal cracks may be sealed with 5-Minute Epoxy

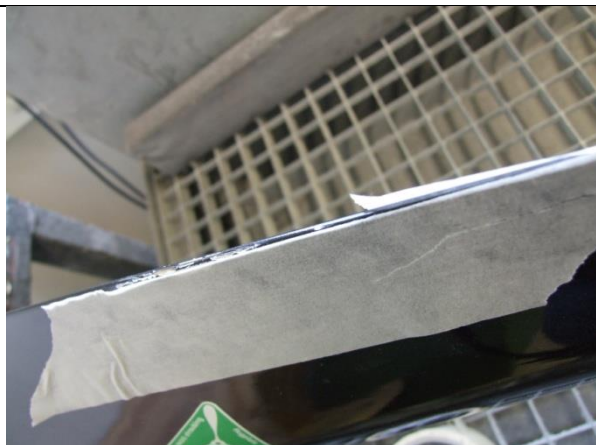
If the fiberglass shell on the trailing edge is delaminated the shell may be rebonded.  
Let pour 5 minute Epoxy into the trailing edge crack.

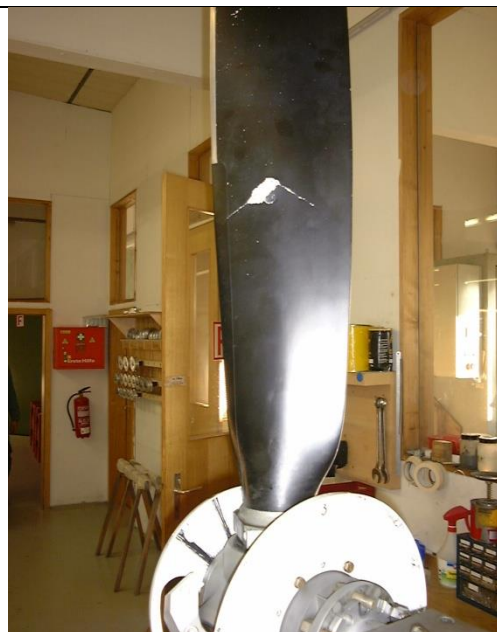
Blade surface damage obviously  
exceeding the field repair limits

Blades with surface damage above 12 mm x 12 mm (0.5 in x 0.5 in) must be sent to the manufacturer or to an authorized service station for repair as soon as possible.

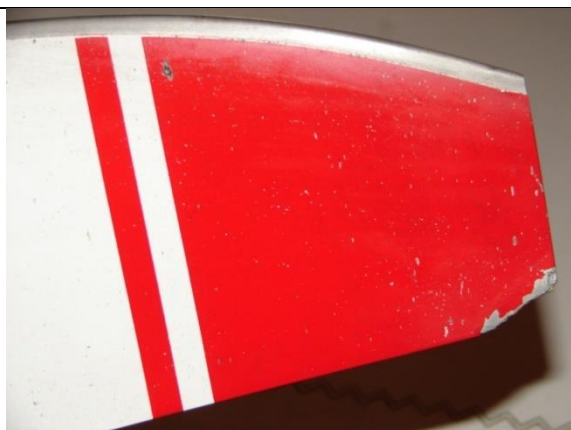
Hangar Damage: Broken Tip Trailing Edge  
Seal with 5 Minute Epoxy or permanent repair with Fiber Glass.

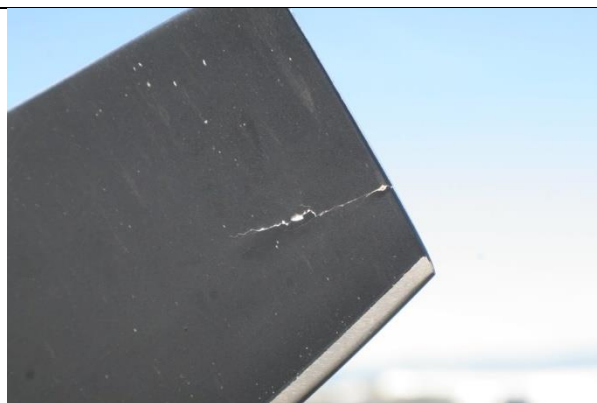
Split Blade tip. Repair with fiber glass

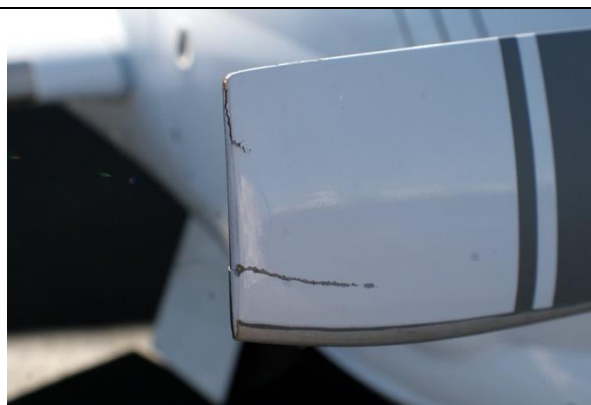
Split Blade Tip and delaminated trailing Edge.  
Rebond Trailing Edge with 5 Minute Epoxy.  
Repair split Tip with Fiber Glass
