| | <b>Service Letter<br/>SL 34-1</b> | DO - No.<br>EASA.21J.020 |

MTV-6-()-() with Fluid Deice System.

MTV-6-()-() propeller hub : A-900-I / A-1677

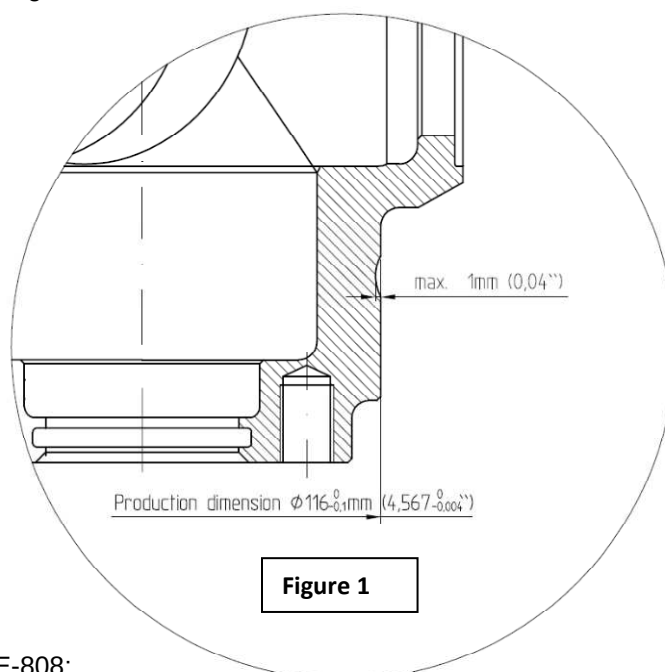
**Figure 1**
**Publications Affected:**

Improper clearances on the area of the propeller hub to the fluid deice nozzle which causes grinding marks on the propeller hub surface.

Measure the depth of the grinding mark according to Figure 1.

If the grinding mark does not exceed 1 mm (0,04 inch) in radius or 2 mm (0,08 inch) in diameter, the propeller may remain in service after an in-field repair.

Carefully smoothen the affected area using abrasive paper or linen starting with grid number 200 and finish with grid number 400.

Protect the affected surface against corrosion with Alodine.
