| | <b>Service Letter<br/>SL 41 R1</b> | <b>DO - No.<br/>EASA.21J.020</b> |

Optional Replacement of Return Spring, part no. A-880, by new Return Spring, part no. A-1772 and A-1771-1.

MTV-12- ( )-C-F

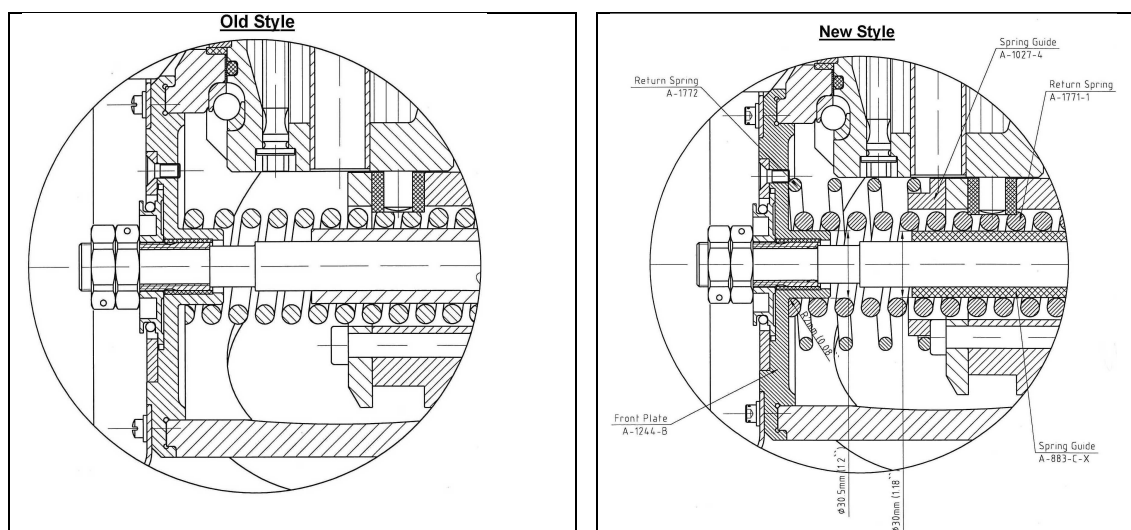
### Material Information:

Under some circumstances the pitch change behavior is sluggish.

Due to installation of stiffer return springs the pitch change behavior is improved.

Due to the replacement of the return spring also other parts have to be exchanged and/or modified in this connection as well as according to the information as listed below.
