| | <b>Service Letter<br/>SL No. 46</b> | <b>DOA No.<br/>EASA.21J.020</b> |

# **IMPORTANT INFORMATION**

**Affected Parts:** Fittings installed on Unfeathering Accumulator P-893-( )/P-905-( )

**Affected Aircrafts:** All Diamond DA 42 with Thielert/Austro/Lycoming engine

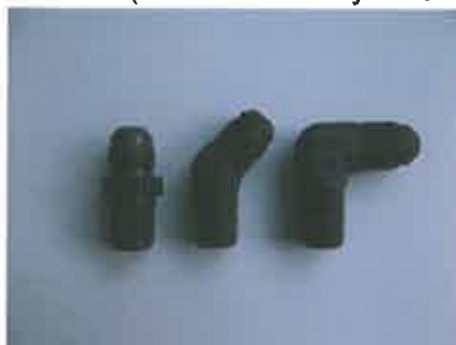
**Description:** The following Fittings C-181-1 (0°), C-167 (45°), C-168 (90°) are installed on the Unfeathering Accumulator P-893-( )/P-905-( ) which are manufactured **before** March 2009 (Part No. accessory Cover A-1439-A)

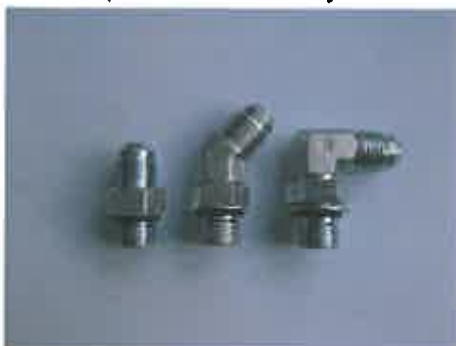
The following Fittings C-179 (0°), C-177 (45°), C-178 (90°) are installed on the Unfeathering Accumulator P-893-( )/P-905-( ) which are manufactured **after** March 2009 (Part No. accessory Cover A-1439-B)
