| | <b>Service Letter</b><br><b>SL No. 49 R9</b> | DOA No.<br>EASA.21J.020 |

**Re-Positioning of de-ice cables to improve long time wear. During the next inspection/repair or overhaul the de-ice cables should be re-oriented to reduce the wear.**

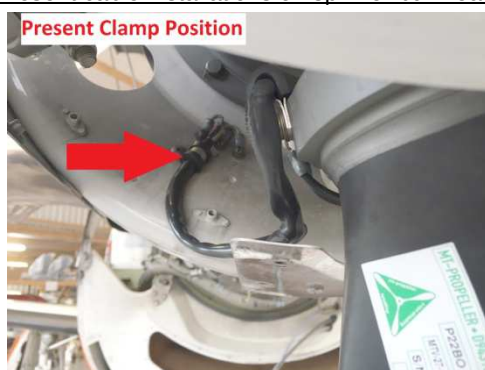
During operation some wear on the de-ice cables were reported.

Present cable installations on spinner bulkhead

- ✦ Clamp on the connectors according to the picture New Clamp Position.
- ✦ Check de-ice cable length (New part number de-ice cable **4E2071-2** or **4H2071-2**)
- ✦ The 10 spinner screws C-306-8 (AN526C1032R8; overall length 15 mm/0,59 inch) used to mount the filler plate  
to the spinner dome between front and rear spinner bulkhead should be replaced by the 10 spinner screws C-306-7 (AN526C1032R7; overall length 13,72 mm / 0,54 inch) that they do not protrude the self locking nut which can wear out the de-ice cable.

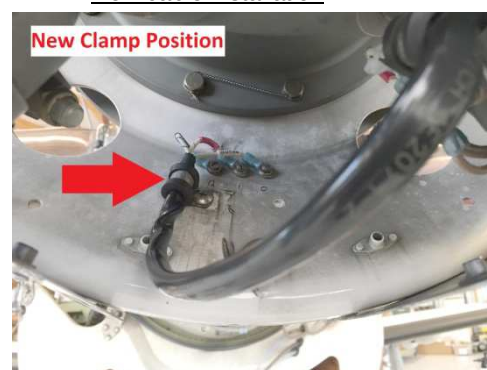
New cable installation

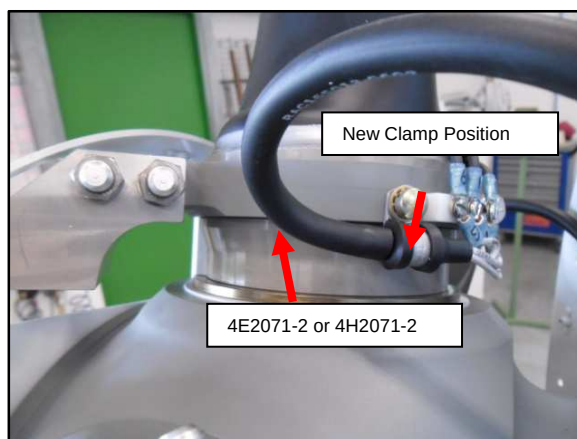
New cable installation on counterweight body

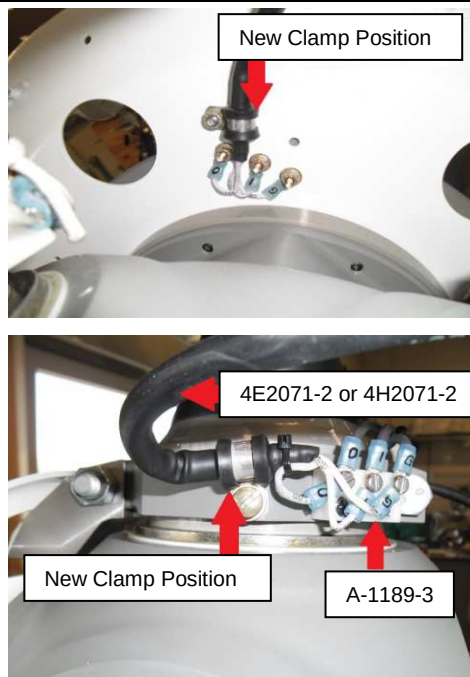
New cable installation on rear spinner bulkhead and counterweight body

Check de-ice cable length (New part number de-ice cable **4E2071-2** or **4H2071-2**)

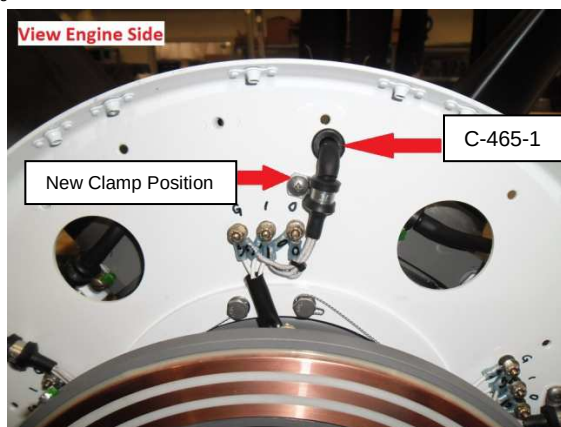
Fig. 2

**New cable installation on rear spinner bulkhead**

1. To reposition the clamp make a new 0,433"(11 mm) bore ; 0,393"(10 mm) left from the old cable clamp location and 0,984"(25 mm) rectangulaire high as shown in Fig.1 .
2. Deburr the new bore and install rubber protection C-465-1 .
3. Install clamp with cable at new location (Engine Side) according the picture on the right side of the cable connectors(Engine Side) as shown in Fig 2.

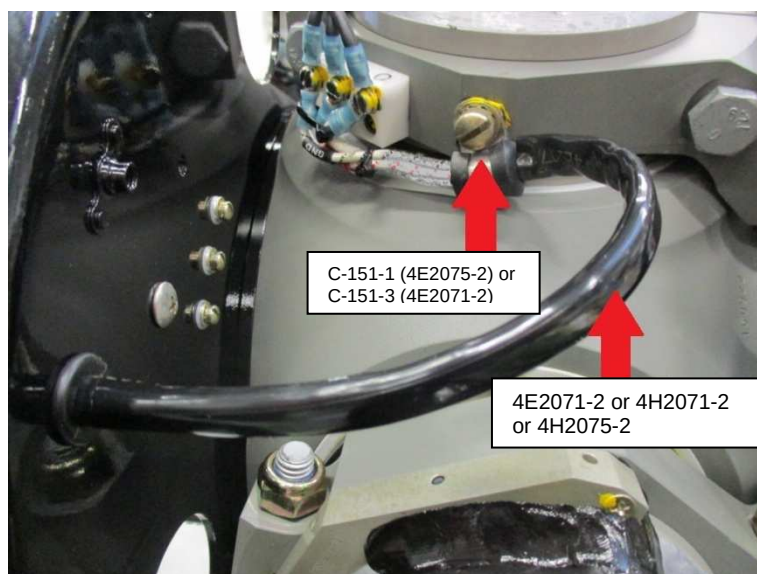
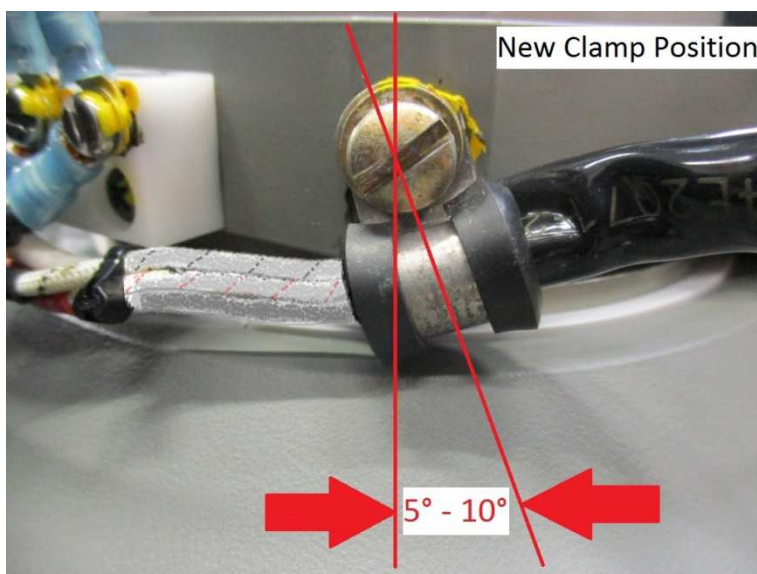
Or optional improved cable installation with 4E2075-2 cable and C-151-1 clamp

The removed vulcanized rubber on one side of the wire 4E2075-2 will give the cable on the counterweight side more flexing and can improve the life time.

**Note:** The new clamp position is applicable on all cable types.

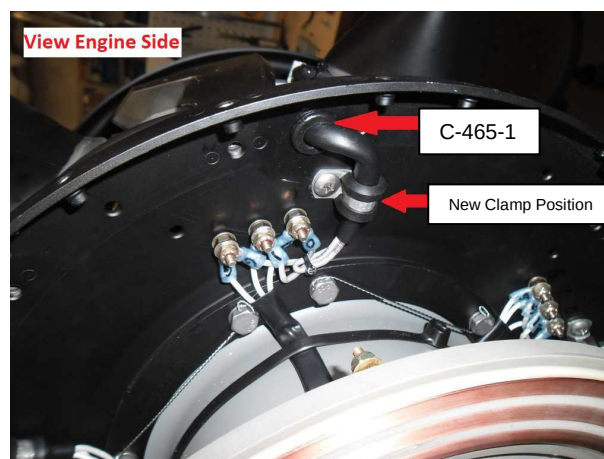
Fig. 4

**New cable installation on rear spinner bulkhead**

1. To reposition the clamp make a new 0,433"(11 mm) bore ; 0,629"(16 mm) left (CFRL Application)/right (CFR Application) from the old cable clamp location and 0,866"(22 mm) rectangulaire high as shown in Fig.3 .
2. Deburr the new bore and install rubber protection C-465-1.
3. Install clamp with cable at new location (Engine Side) according to Fig 4.

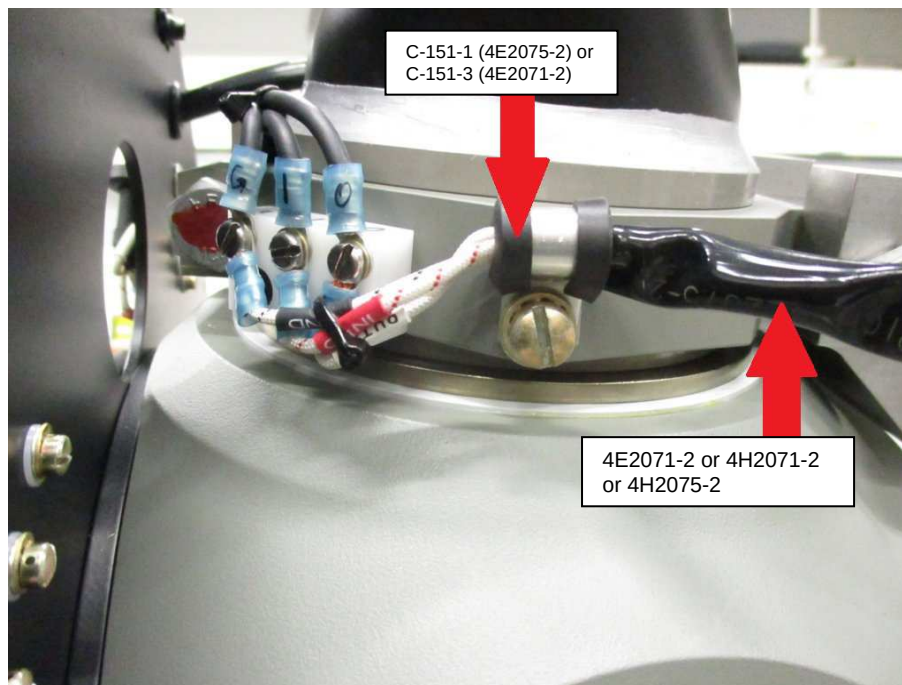
Or optional improved cable installation with 4E2075-2 cable and C-151-1 clamp

The removed vulcanized rubber on one side of the wire 4E2075-2 will give the cable on the counterweight side more flexing and can improve the life time.

**Note:** The new clamp position is applicable on all cable types.

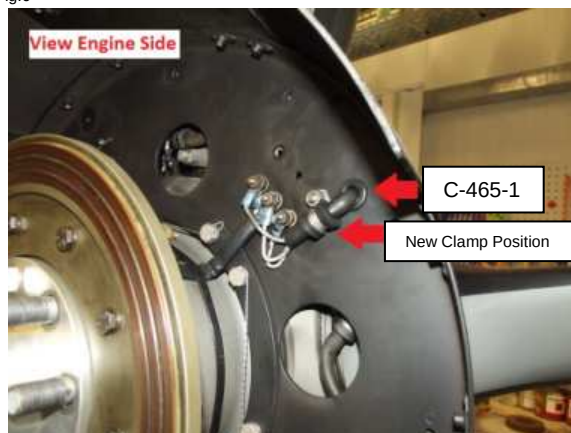
Fig.6

**New cable installation on rear spinner bulkhead**

1. To reposition the clamp make a new 0,433"(11 mm) bore ; 0,590"(15 mm) left (CFRL Application)/right (CFR Application) from the old cable clamp location and 0,629"(16 mm) rectangulaire high as shown in Fig.5 .
2. Deburr the new bore and install rubber protection C-465-1 .
3. Install clamp with cable at new location (Engine Side) according to Fig 6.

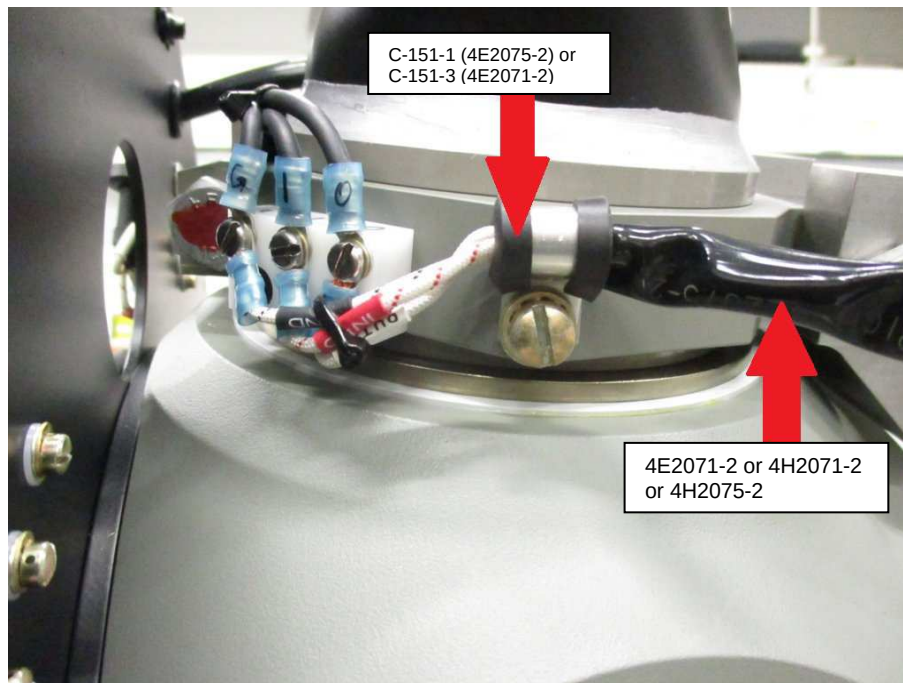
Or optional improved cable installation with 4E2075-2 cable and C-151-1 clamp

The removed vulcanized rubber on one side of the wire 4E2075-2 will give the cable on the counterweight side more flexing and can improve the life time.

**Note:** The new clamp position is applicable on all cable types.
