| | <b>Service Letter<br/>SL 52-2</b> | DO - No.<br>EASA.21J.020 |

**Removal of inner propeller spring on counterweighted MT-Propeller.**

Affected Aircraft: Grob G115E  
Affected Propeller: MTV-12-B-C/C183-17e installed per EASA STC.10043263

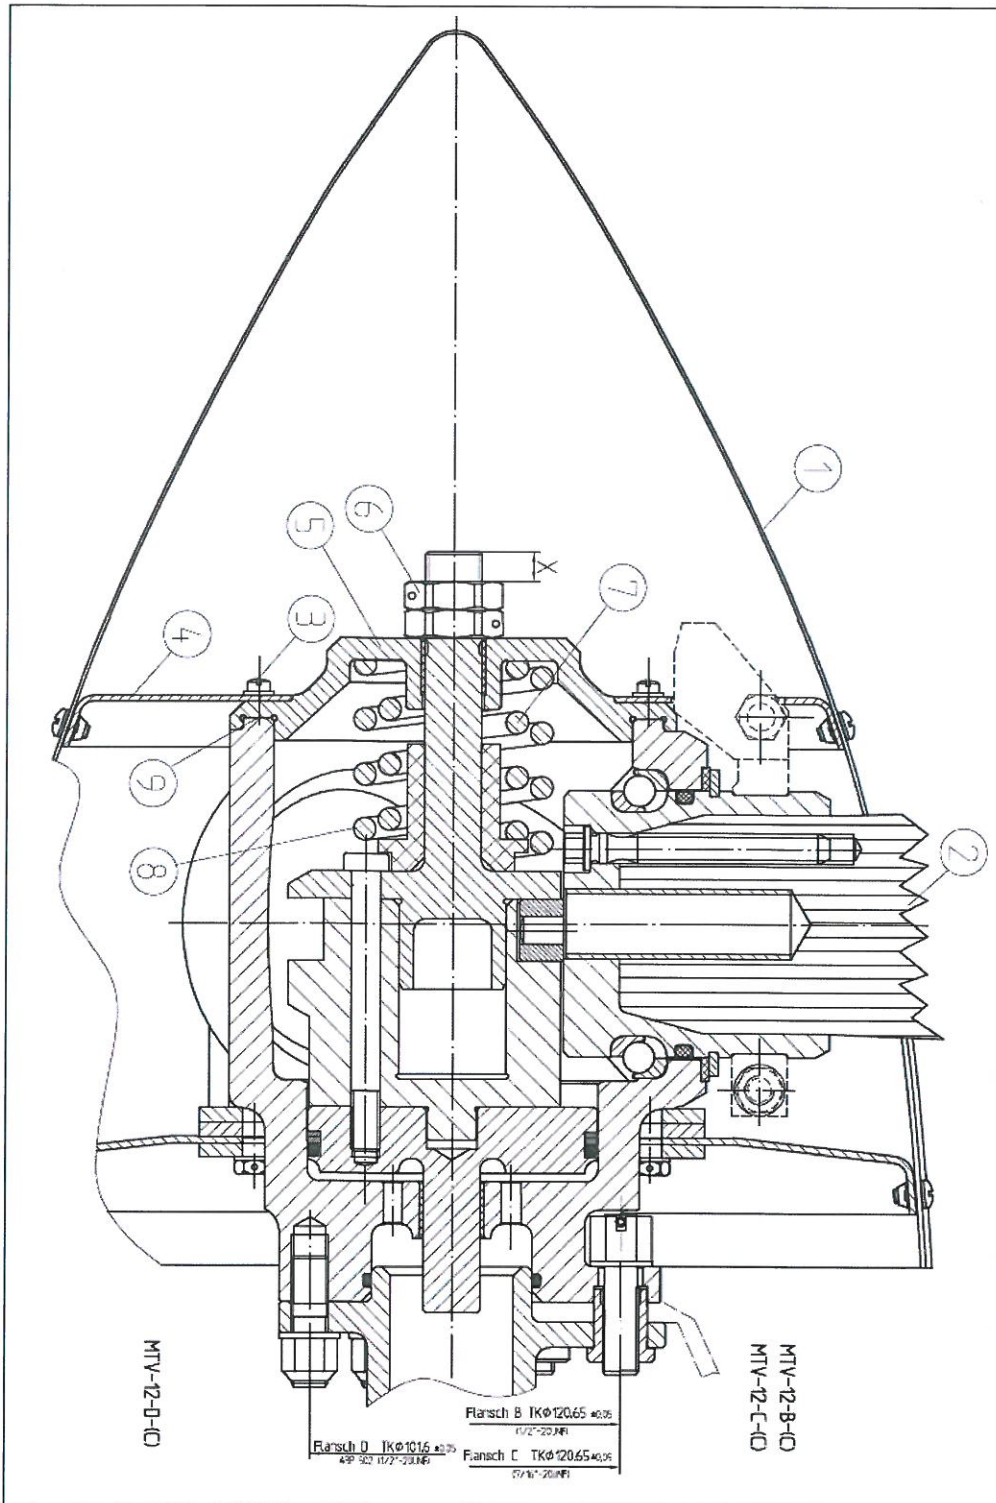
Drawing 1: MTV-12-B-C assembly drawing

On some Grob G115E airplanes propeller speed surges were observed due to engine oil pressure fluctuations during some aerobatic manoeuvres.

In normal operation the propeller governor is supplied with engine oil from the engine oil system. During aerobatics short engine oil pressure dropouts may occur. This results in insufficient oil supply to the propeller governor. The propeller MTV-12-B-C/C183-17e is controlled with oil pressure to decrease pitch. In case of oil pressure loss the counterweights and the springs inside the hub will turn the blades towards high pitch. In this case the amount of the RPM-drop depends on the length of the oil supply dropouts.

The removal of one (inner) spring reduces the spring force which turns the blades in the high pitch position. This allows a lower oil pressure to control the blade pitch.

1. Unscrew the spinner screws and remove the spinner dome (1).
2. Use a vernier caliper to measure the dimension X shown in the drawing below. Note the dimension; it is important to set the high pitch position accordingly.

3. Use a marker pen to mark the two check nuts, rod and front plate (5) relative position.
4. Remove the 12 front plate screws (3) and spinner front plate (4).

5. Remove propeller front plate (5) by releasing and removing the check nuts (6).

6. Remove the propeller inner spring (7).

7. Ensure that the outer spring (8) remains in place.
8. Bring propeller front plate (5) into position by pressing it down with one check nut (6). Ensure the breather hole in the front plate aligns with blade No. 1.
9. Apply sealing material RTV 109 or similar on parting line (9) only outside not on the parting surface.

10. Align blade No. 1 index on spinner front support (4) with blade No. 1 and fasten all 12 front plate screws (3) with 6 – 6,5 Nm (52-57 inlbs).
11. Safety wire the front plate screws using 0.025 inch (0,63 mm) standard safety wire.
12. Install both check nuts with the attaching side against each other. Readjust to dimension X and ensure the marks previously applied are aligned and torque the nuts against each other (90 Nm – 100 Nm / 797 inlbs – 885 inlbs). Recheck dimensions A by using the depth function of a vernier caliper.
13. Safety wire the check nuts using 0.032 inch (0,81 mm) standard safety wire.
14. Carry out a duplicate inspection for your Airworthiness Authority if required.
15. Reinstall the spinner taking note of the correct position in relation to blade No. 1.
16. Perform an engine check run and make logbook entries.
