| | <b>Service Letter<br/>SL 57 R1</b> | <b>DO - No.<br/>EASA.21J.020</b> |

## Planning Information

Re-Positioning of de-ice cables to improve long time wear. During the next inspection/repair or overhaul the de-ice cables should be re-oriented to reduce the wear .

MTV-27-1-N-C-F-R(G)-J / CFR285-82 / CFRL285-82 with spinner assembly P-1152-( ) installed on Jetstream 41;

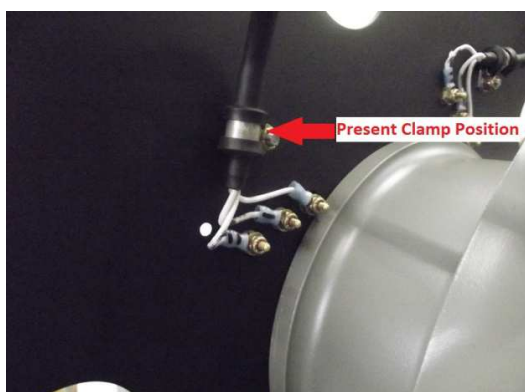
During operation some damages on the de-ice cables were reported.

Present cable installation spinner bulkhead and counterweight body

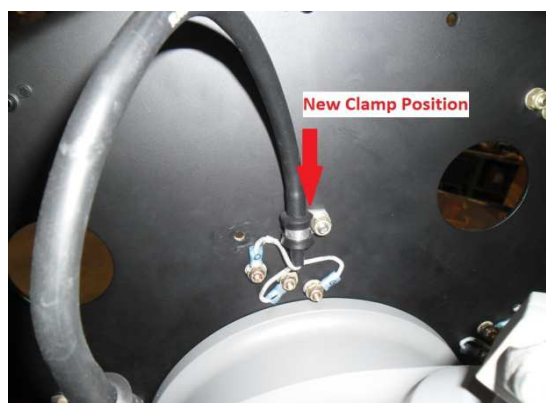
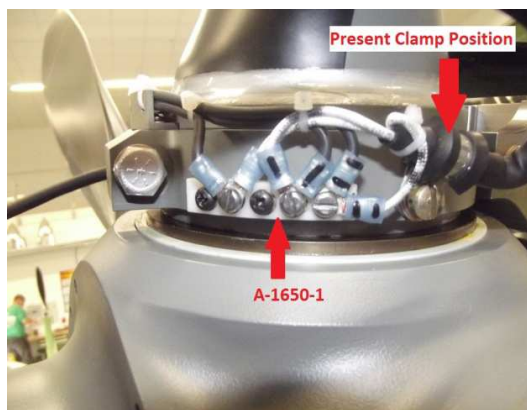
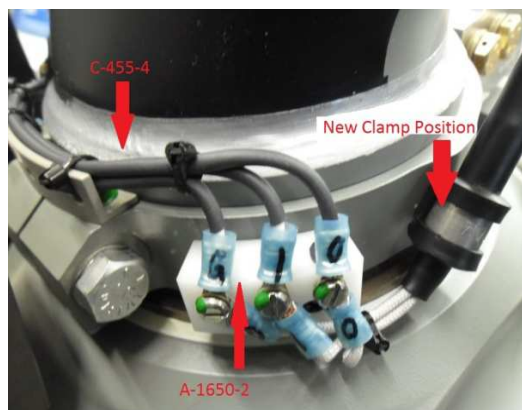
New cable installation

- Cable clamp repositioning and replacement of Clamp A-1650-1 by A-1650-2
- Stop nut are reusable up to 3 times
- No special tools required
