| | <b>Service Letter<br/>SL 58</b> | <b>DO - No.<br/>EASA.21J.020</b> |

## Removal of inner propeller spring on counterweighted MT-Propeller.

Affected Aircraft: Extra 300 Series , Cap 231/EX/232 Series  
Affected Propeller: MTV-14-B-C/C190-17

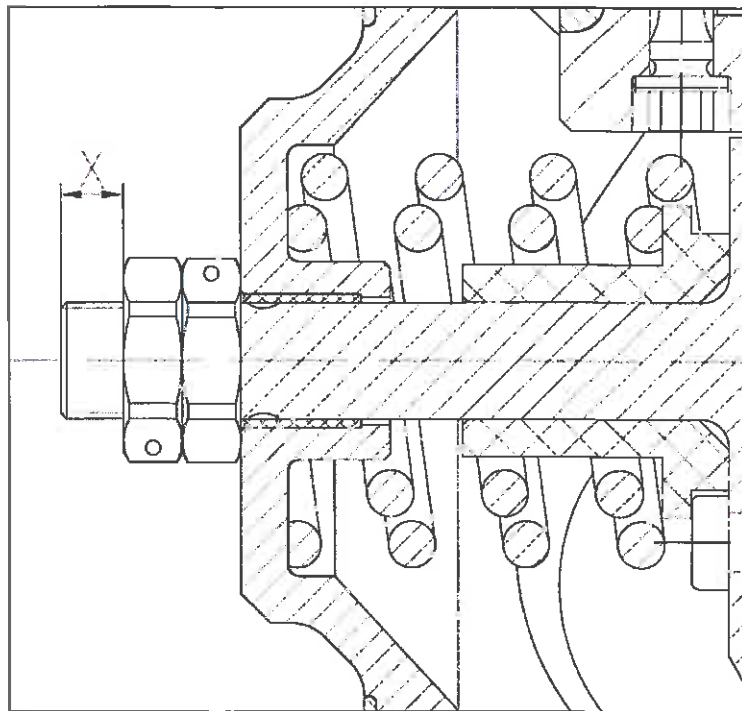
1. Unscrew the spinner screws and remove the spinner dome (1).
2. Use a vernier caliper to measure the dimension X shown in the drawing below. Note the dimension; it is important to set the high pitch position accordingly.
