| | <b>Service Letter</b><br><b>SL 59</b> | <b>DO - No.</b><br><b>EASA.21J.020</b> |

Counterweight body crack inspection( Magnetic particle inspection)

All counterweighted variable pitch MT Propeller

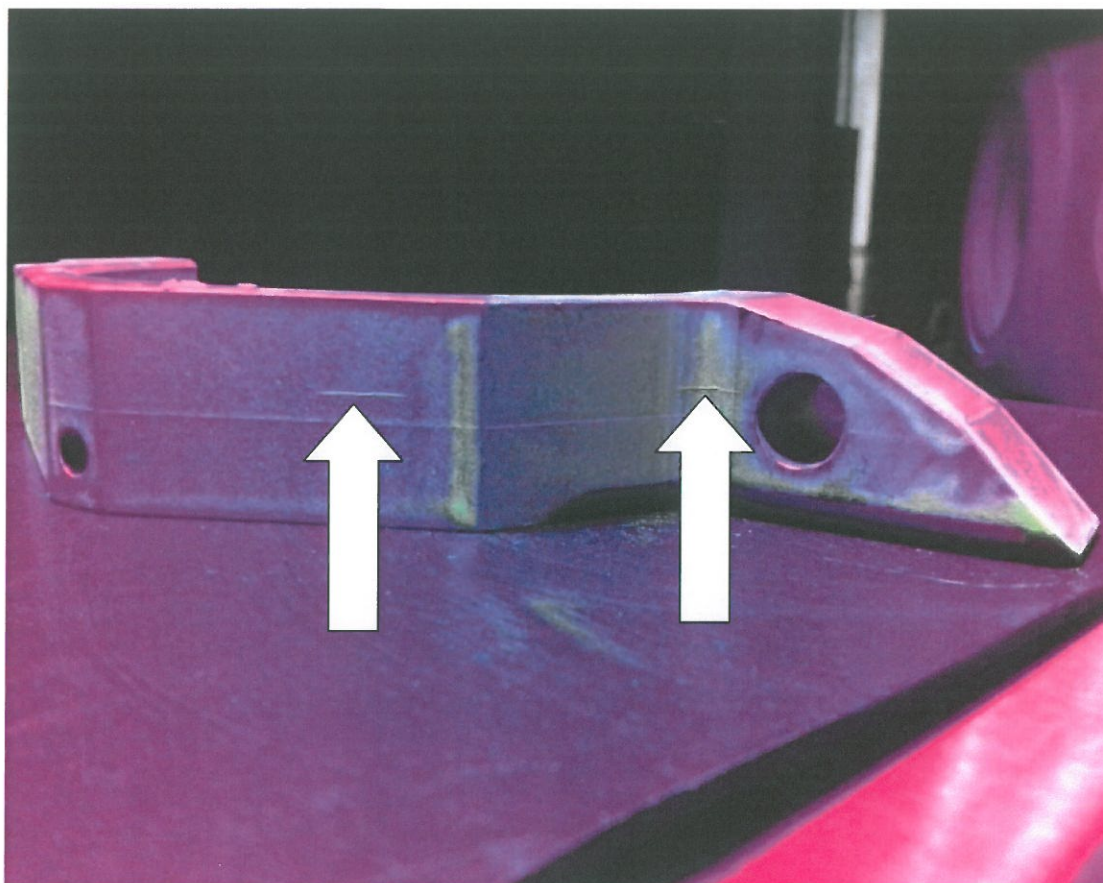
Fig.1

During the magnetic particle inspection some material manufacturing characteristics (see Marks on Fig 1, Fig 2, Fig 3) were found.

Such indications do not affect the strength of the counterweight.

No action required, such counterweight bodies can go in service again.
