| | <b>Service Letter<br/>SL 60</b> | <b>DO - No.<br/>EASA.21J.020</b> |

## Modification of Counterweight Body A-1496-( ) Y( )

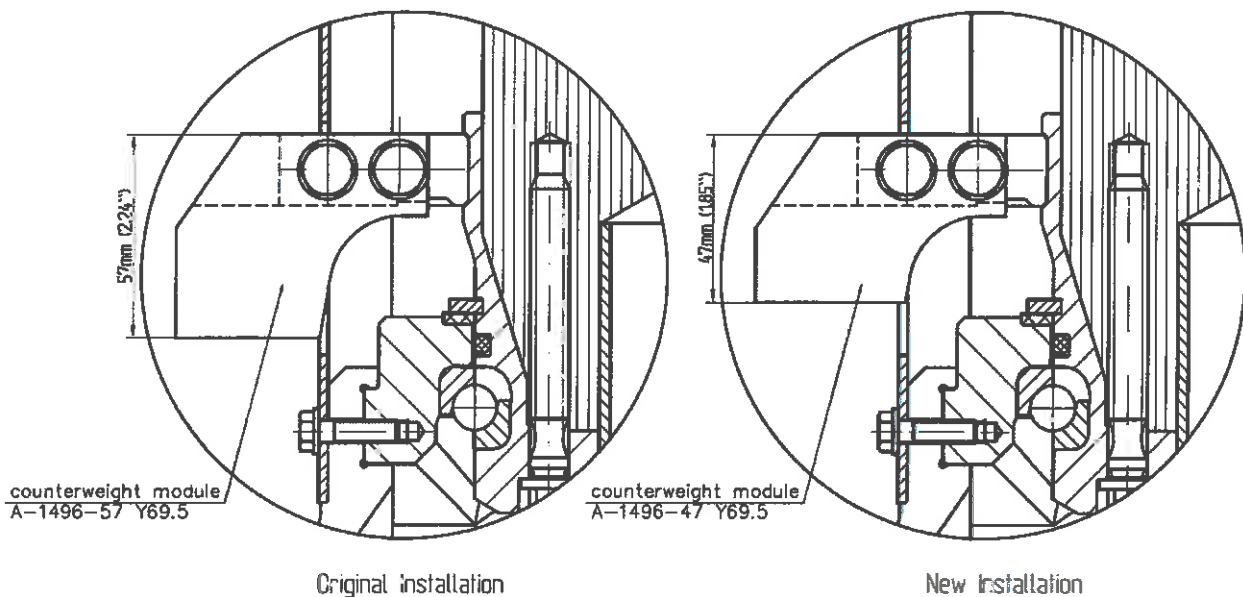
Counterweight body A-1496-57 Y69.5 must be modified to Counterweight body A-1496-47 Y69.5 by reducing the total height by 10mm or a new counterweight body.

Reduction of loads on pitch change parts and therefore reducing the long time wear.

This modification reduces the wear due to reduced loads by 60% on the pitch change parts.

Reinstallation according to SL15.

**Individual** replacement is not allowed, only a complete set of 4 counterweight bodies per propeller must be replaced.
