| | <b>Service Letter<br/>SL 63</b> | <b>DO - No.<br/>EASA.21J.020</b> |

## Inspection of Beta Valve P-846 / Prop front O-Ring for possible Oil Leak installed on RR250 engines

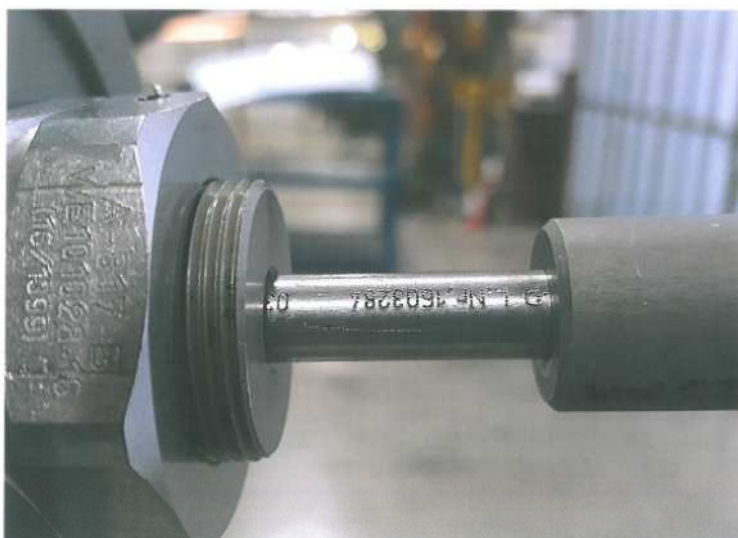
Some Beta tubes P-846 have a marking in the front part of the beta tube as shown below:

In case the marking shows some roughness, the beta tube can be polished using a sand paper to smoothen the surface reducing the O-Ring C-199 wear, causing also a possible oil leak.

Picture shows the beta tube with the propeller feathered. The O-Ring C-199 is approximately 8mm inside the guide rod shown on the picture.

To polish the marking on the beta tube, the propeller must be removed.

In case the marking cannot be polished to have a smooth surface, contact: techsupport@mt-propeller.com for a exchange beta tube P-846.
