| | <b>Service Letter<br/>SL 64</b> | <b>DO - No.<br/>EASA.21J.020</b> |

**Alternative Positioning of MT-Propeller Identification Label****Affected Propeller:**

All MTV-Propeller which have no identification label on the propeller blade

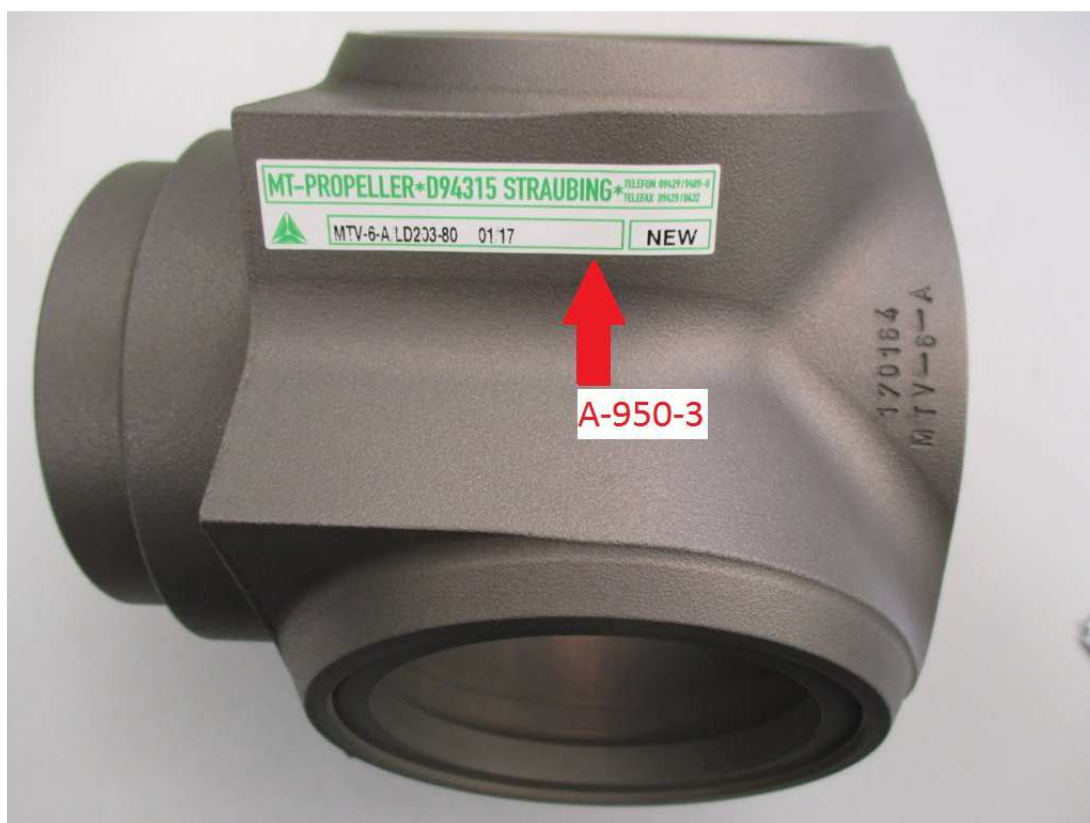
If the propeller blade has no identification label stuck on, an alternative positioning of the MT-Propeller identification label ( part number A-950-3 ) is optional possible as shown on the picture below.
