| DO - No.<br>EASA.21J.020 | <b>Service Letter<br/>SL 70</b> | Revision 0 |

### **Propeller Snap Ring MTV-33-( ) and MTV-34-( ) Propeller**

**Affected Propeller:** MTV-33-( ) and MTV-34-( ) Propeller manufactured, overhauled, or repaired until 11/2019

**Reason:** Definition of tolerances for damaged and/or missing parts of snap rings

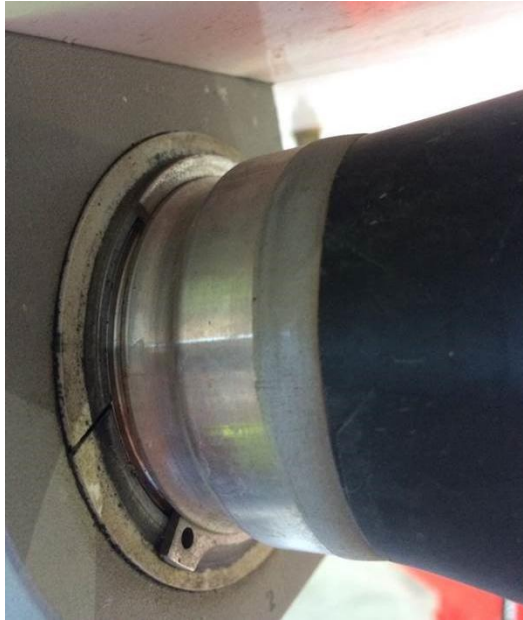
To illustrate the tolerance described above the following page shows two pictures of damaged snap rings which still have more than 2/3 of their circumference intact.

Figure 1: Example of damaged snap ring still in place

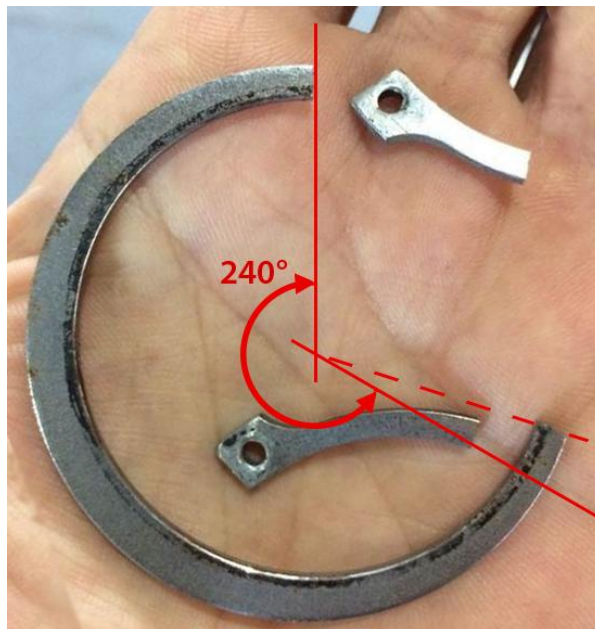
***Damaged snap rings that still have 2/3 or more of their circumference intact (see Figure 2) are not a safety issue and aircraft operation may continue.***

Figure 2: Example of damaged snap ring with more than 2/3 of circumference intact

Operation of the propeller without snap rings may result in excessive grease leak due to excessive wear during engine start and shutdowns. Continued operation is therefore not recommended and the damaged snap rings must be replaced in case their damage is out of the stated tolerance.
