| | <b>SERVICE LETTER</b><br><b>SLE No. 77 - Original Issue</b> | DOA No.<br>EASA.21J.020 |

**Subject:** Length of the spinner fixture screws installed on spinner assembly part number P-1741-( )

**Affected Propeller:** MTV-27-1-N-C-F-R(P)/CFR260-65b with spinner assembly part number P-1741-( )

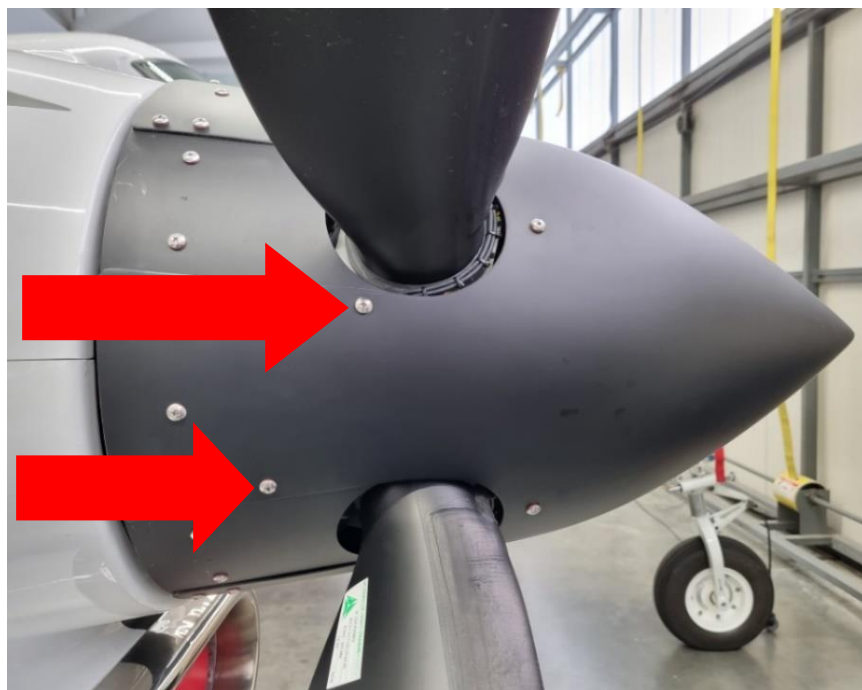
**Reason:** The length of the spinner screw C-306-9 could cause wear of the de-ice cables which are installed from the spinner bulk head to the connecting terminal on the blade counterweight clamp.

**Action:** The 10 red marked spinner screws C-306-9 (overall length 16,5 mm / 0,65 inch) should be replaced by the 10 shorter spinner screws C-306-8 (overall length 15 mm / 0,59 inch) which fixing the filler plate on spinner dome between front and rear spinner bulkhead.
