| DO - No.<br>EASA.21J.020 | <b>Service Letter<br/>SL 81</b> | Original Issue |

**Subject:** Possible Grease Leak and High Friction of Blade Preload after or during Assembly

**Type Affected:** All blade O-rings, C-057-( )-R, all models of a certain production batch.

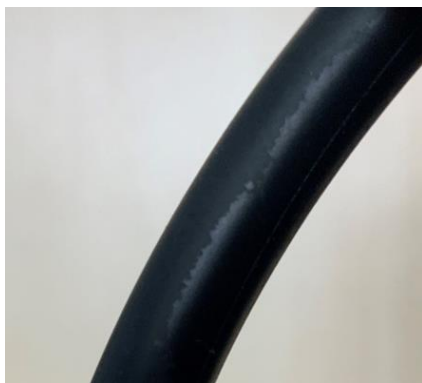
Fig. 1

**Accomplishment:** Affected O-rings can be identified by the batch number or stretching the O-ring with your fingers and rubbing the surface. If the O-Ring is affected by the improper surface finish, it can be identified according to Figure 1.  
If you have a good O-ring surface finish, a smooth uniform surface, even after rubbing, as shown in Figure 2, is found.  
This test can be done before assembly. Replacement O-rings are available from MT-Propeller.

**Reason:** Due to a different manufacturing technic of the O-ring manufacturer, lose particles of the surface layer can lead to grease leakage or high friction of blade preload.
