| DO - No.<br>EASA.21J.020 | <b>Service Letter<br/>SL 82</b> | Original Issue |

### Instructions for grounding of non-insulated electrically controlled governor

**Type Affected:** P-853-16, P-877-16 (Electr. contr. governors with non-insulated head)

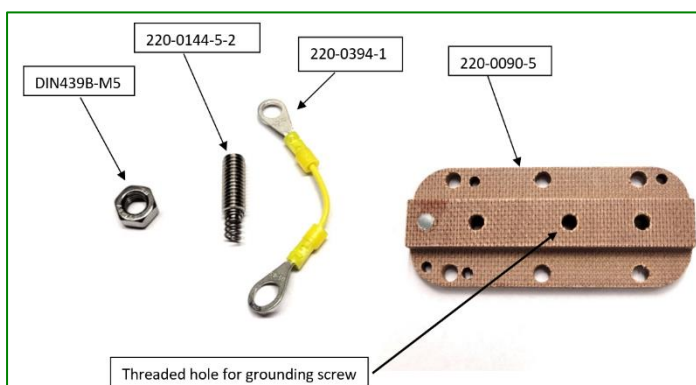
Figure 1

**Parts Needed:** See Figure 1.
