**ATA 61-05-70**

**OPERATION AND INSTALLATION MANUAL**

**HYDRAULICALLY CONTROLLED  
VARIABLE PITCH PROPELLER**

**MTV - 8 - ( )**

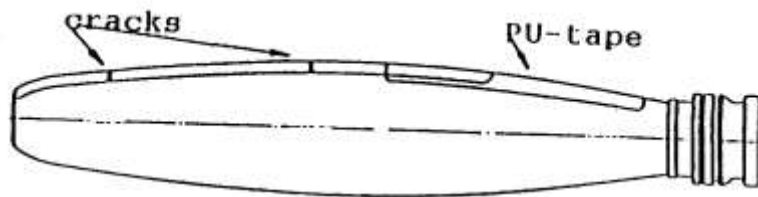
Cracked erosion sheath requires immediate repair. If chordwise cracks appear, return propeller to manufacturer. Replace PU-tape as soon as possible, if loose or damaged.
