| DOA - No.<br>EASA.21J.020 | <b>Service Letter<br/>SL 32</b> | Revision 9 |

## In-Field Repairs

All MT-; MTE- and MTV- Propellers with Natural Composite Blades!

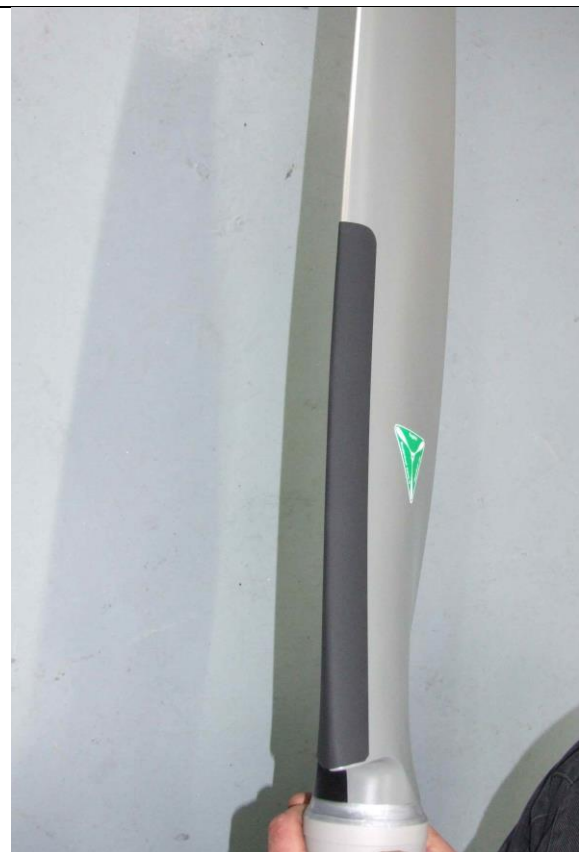
Undamaged PU-Erosion Sheath.

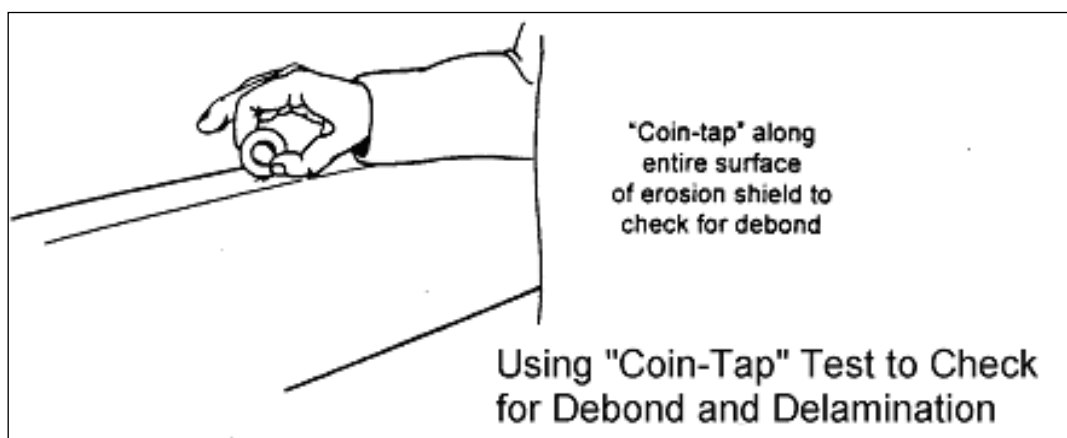
Whenever performing pre-flight inspection, monitor whether there are further delamination and/or whether the already existing delamination has become worse.

The inspection can be executed by using an appropriate coin (Tap-Test).

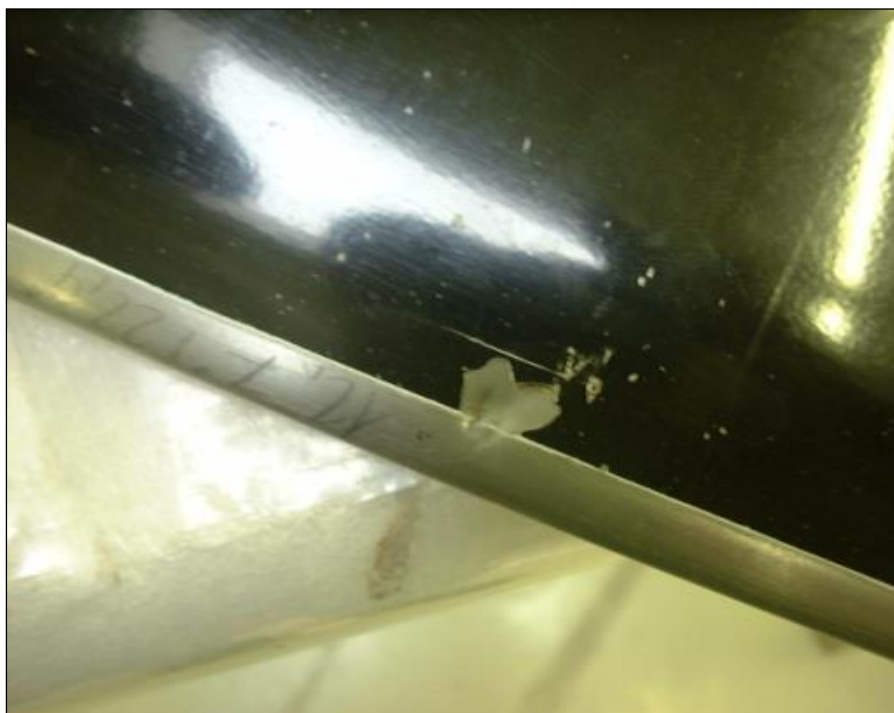
- ✓ The hollow and debonded spots must not exceed 30% of the surface of the erosion sheath at all (lengthwise only 25 mm (1.0 in) are allowed).
- ✓ Hollow and debonded spots (max. 0.39 square in\* / 2.5cm<sup>2</sup>), no two spots may occur within 130 mm (5.0 in) of each other.
- ✓ Debonded areas which result in an open bonding crack must be sealed in order to prevent water from penetrating.
- ✓ The length of open bonding cracks must not exceed 25 mm (1.0 in)!

- ✓ Bonding cracks which are not open to the blade tip may be resealed by using 5-Minute Epoxy.

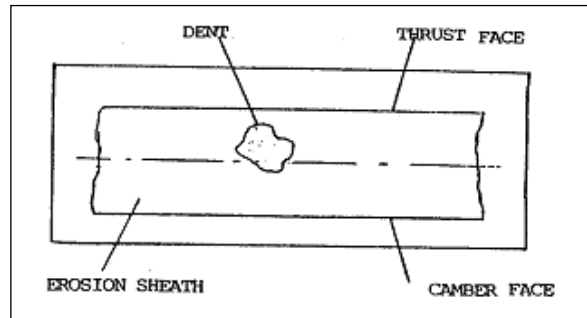
- ✓ Circular dents not more than 0.24 in x 0.24 in (6 mm x 6 mm)
- ✓ Pointed dents not more than 0.24 in x 0.24 in (6 mm x 6 mm)
- ✓ If within 51 mm (2.0 in) no other dents of that size are visible, the dent size may exceed the original maximum size by 3 mm (0.12 in) to a maximum of 9 mm x 9 mm (0.36 in x 0.36 in).
- ✓ If within 76 mm (3.0 in) no other dents of that size are visible, the dent size may exceed the original maximum size by 5 mm (0.2 in) to a maximum of 11 mm x 11 mm (0.43 in x 0.43 in).

**NOTE:** NEVER FILE A STAINLESS STEEL OR NICKEL LEADING EDGE!

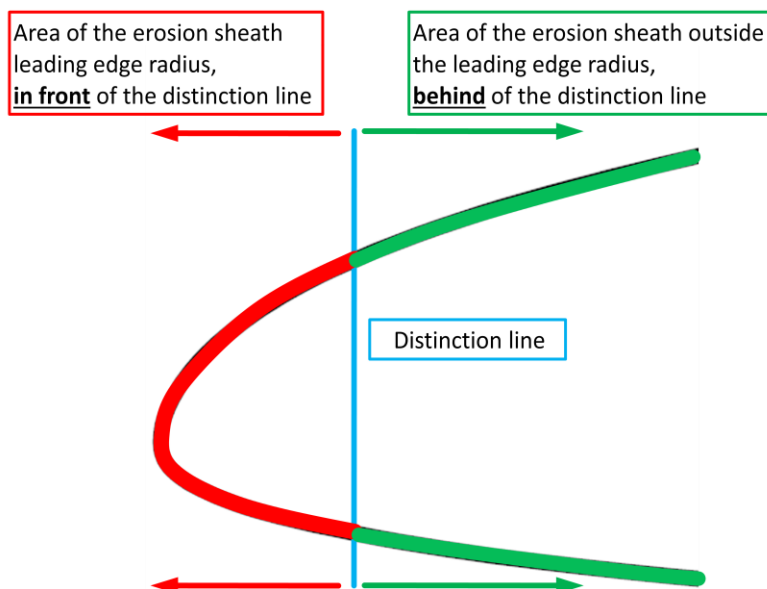
The leading edge radius is most prone to moisture in operation; therefore it needs to be ensured that the natural composite core of the blade is protected against water intrusion. The distinction line is located behind the leading edge radius and determines how to handle a punctured erosion sheath.

Area where the erosion sheath has been punctured **in front of the distinction line**:

- Fill with epoxy to prevent moisture intrusion
- Monitor the area at pre-flight inspection
- Replace the erosion sheath as soon as possible

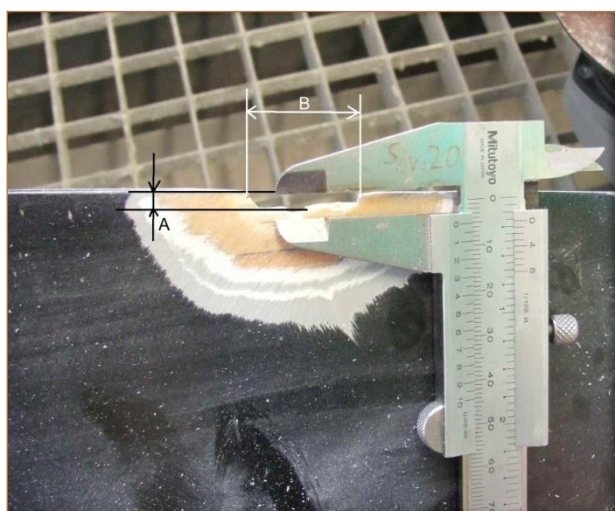
Crunched trailing edges can be sealed by using 5 minute Epoxy if the damage is not deeper (Dimension A) than 5 mm (0.20 in) and not wider (Dimension B) than 15 mm (0.60 in).

Crunched trailing edges can be repaired by replacing the fiber glass cover if the damage is not deeper (Dimension A) than 7.5 mm (0.30 in) and not wider (Dimension B) than 25 mm (1.0 in).

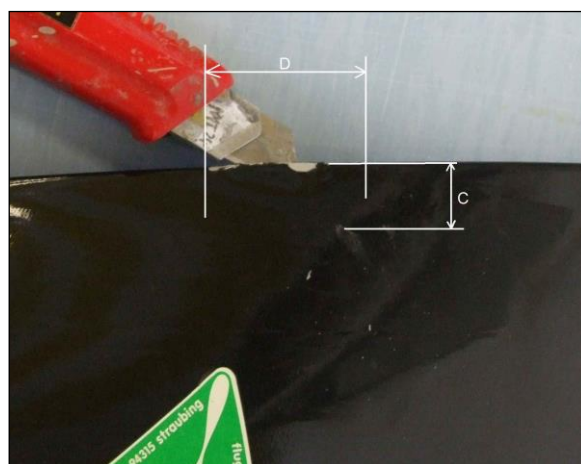
Delaminated fiber glass shell on the trailing edge may be rebonded if the debonding is not deeper (Dimension C) than 12.5 mm (0,5 in) measured from the trailing edge and not wider (Dimension D) than 25 mm (1 in).

**Caution:** Assure that any moisture cannot enter the load carrying blade body.

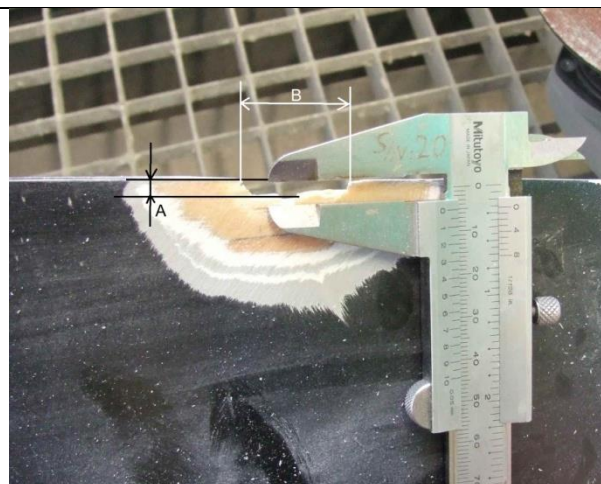
Measure the extent of damage  
Max. 7,5 mm (0.3 in) from Trailing Edge and 25 mm (1.0 in) wide allowed for Field Repair.

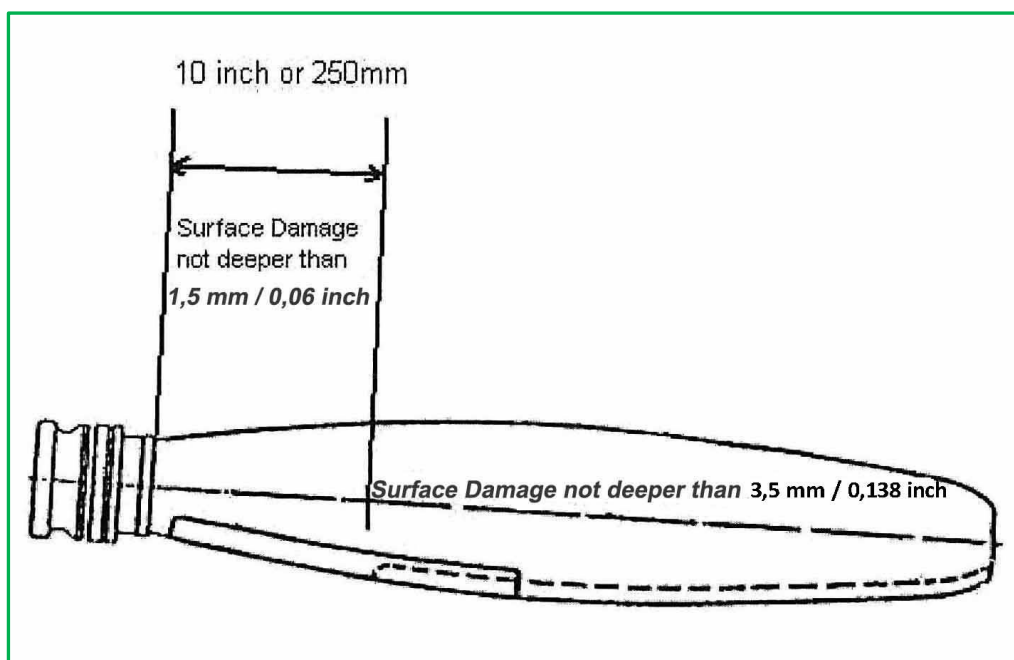
- ✓ There may be no crack in the load carrying natural composite structure beyond the following repair limits.
- ✓ All dimensions are measured after local removal of paint and filler.
- ✓ Blade Root: inside 250 mm (10.0 in) from Blade Ferrule:  
Damage may not be deeper than 1.5 mm (0.06 in.)
- ✓ Blade outside Blade Root: Damage may not be deeper than 3.5 mm (0.14 in).

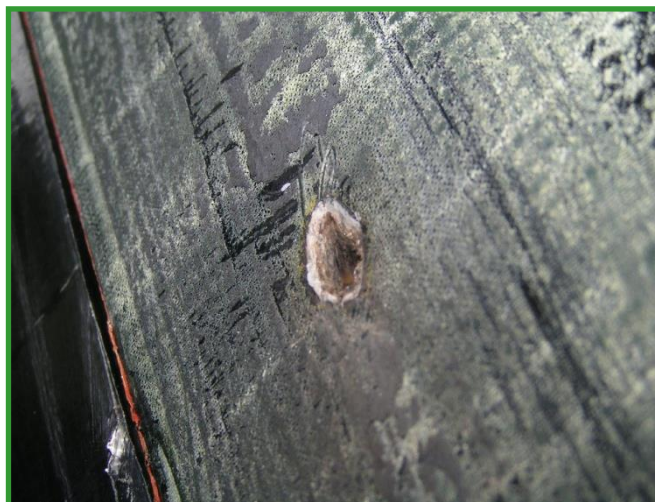
Failed de-ice boots may cause damage to the blade surface structure behind the boot failure.

Maximum damage in the De-Ice Boot area:

14 mm x 8 mm x 1, 5 mm (0.55 in x 0.31 in x 0.06 in)

Such damage may be repaired with 5 Minute Epoxy also.

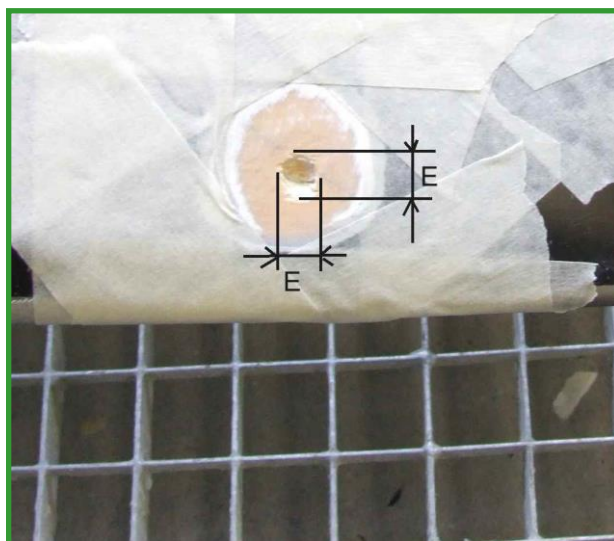
Surface damage whose size (E X E) is above 6mm x 6mm (0.2 in x 0.2 in) but below 12mm x 12mm (0.5 in x 0.5 in) must be field repaired by locally replacing the fiber glass shell.

Blades with surface damage above 12 mm x 12 mm (0.5 in x 0.5 in) must be sent to the manufacturer or to an authorized service station for repair as soon as possible.

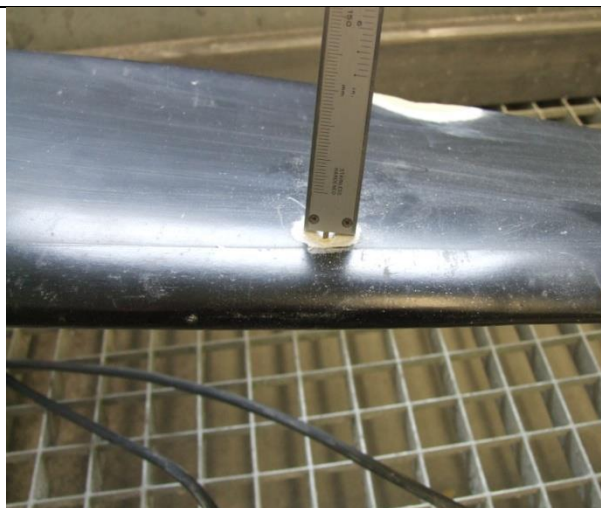
Field Repair Limits:  
Blade Root: inside 250 mm (10.0 in) from Blade Ferrule:  
Damage may not be deeper than 1.5 mm (0.06 in).  
Blade outside Blade Root:  
Damage may not be deeper than 3.5 mm (0.14 in)

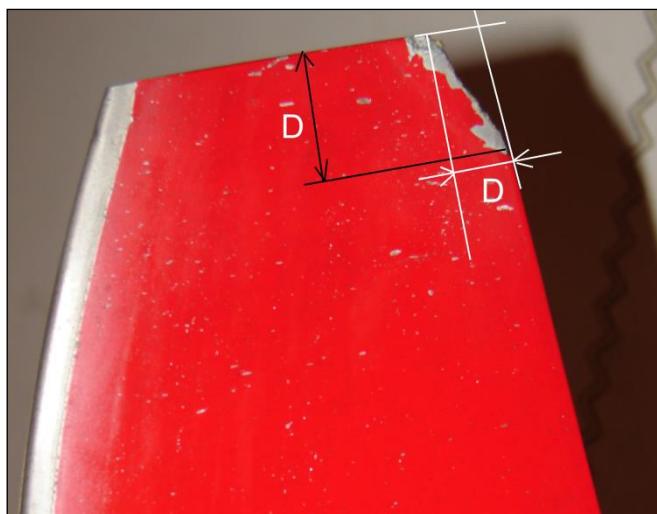
Broken blade tip Trailing edges

Maximum damage size measured from the blade tip trailing edge

Dimension "D" below 12 mm (0.5 in) : Only sealing with 5-Minute Epoxy required.  
Dimension "D" above 12 mm (0.5 in) and below 25 mm (1.0 in) local repair with fiber glass required
