## **OPERATION- AND INSTALLATION MANUAL**

REVERSIBLE HYDRAULICALLY CONTROLLED  
VARIABLE PITCH PROPELLER  
(CONSTANT SPEED PROPELLER)  
for  
**PT6A-67 - Series**

**MTV-16-1-( )-R(P)**  
**MTV-27-1-( )-R(P)**  
**MTV-27-1-( )-R(P)-J**  
**MTV-27-2-( )-R(P)**  
**MTV-47-1-( )-R(P)**  
**MTV-47-1-( )-R(P)-V**

Revision 39: May 15<sup>th</sup>, 2024

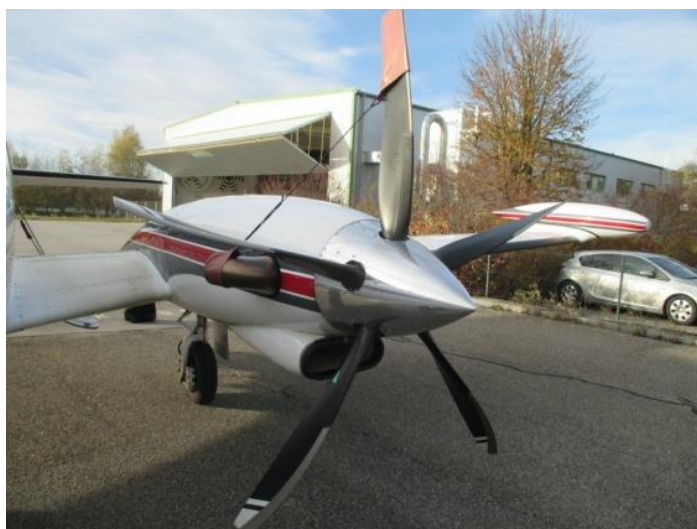
**CORRECT** at outside temperatures above 0°, that no water can accumulate inside the spinner which can freeze and causing an unbalance in operation.

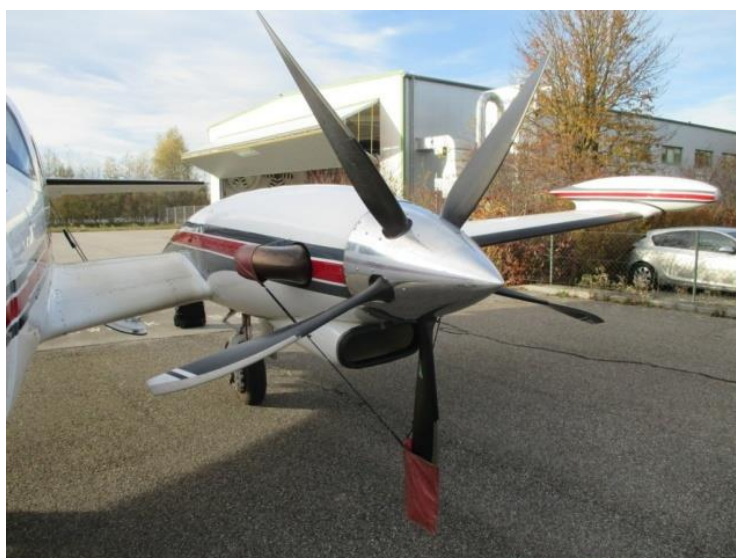
**CORRECT** at outside temperatures below 0°, but make sure the cover is opened that no water can accumulate inside the cover, which could lead to a damage of the blade.
