ATA 61-09-22

**OPERATION-, INSTALLATION- AND  
MAINTENANCE MANUAL**

**REVERSIBLE HYDRAULICALLY CONTROLLED  
VARIABLE PITCH PROPELLER  
(CONSTANT SPEED PROPELLER)**

**MTV-27-1-N-C-F-R(G)-J**

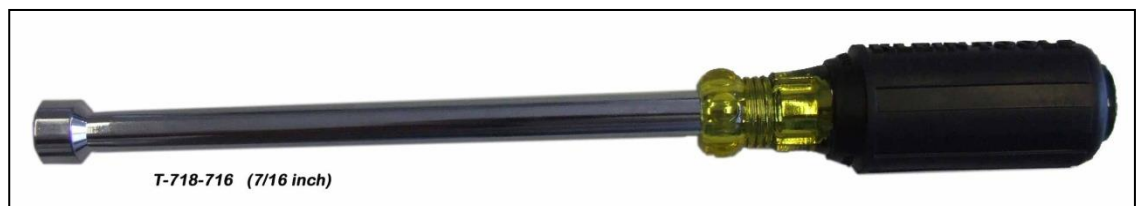
Turning OUT → lower pitch

→ Use Socket Wrench Tool T-718-716 (7/16 inch) for turning stop nuts

All 3 or 4 stopnuts must have the same setting to each other, if not, the pitch change mechanism could be damaged because of the wobbling of the beta-ring.
