**ATA 61-07-19**  
**(E-3719)**

**OPERATION- AND INSTALLATION AND MAINTENANCE  
MANUAL**

**REVERSIBLE HYDRAULICALLY CONTROLLED  
VARIABLE PITCH PROPELLER**

**MTV-28-2-( )-R(H)**

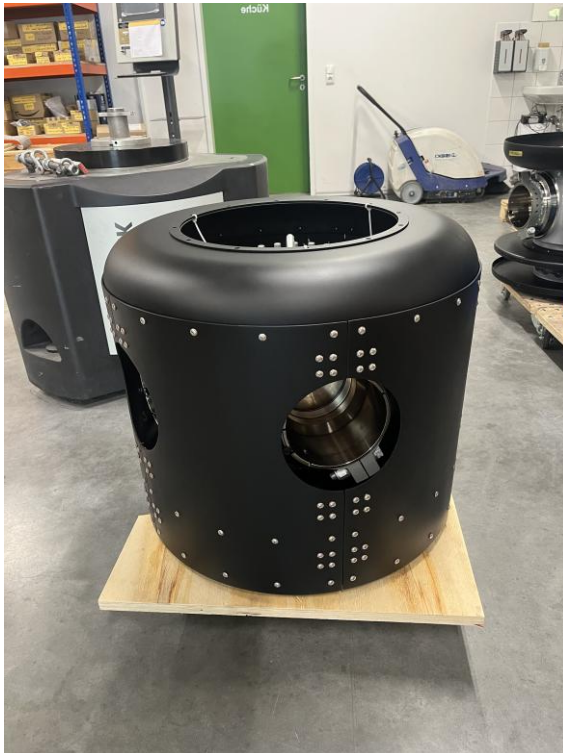
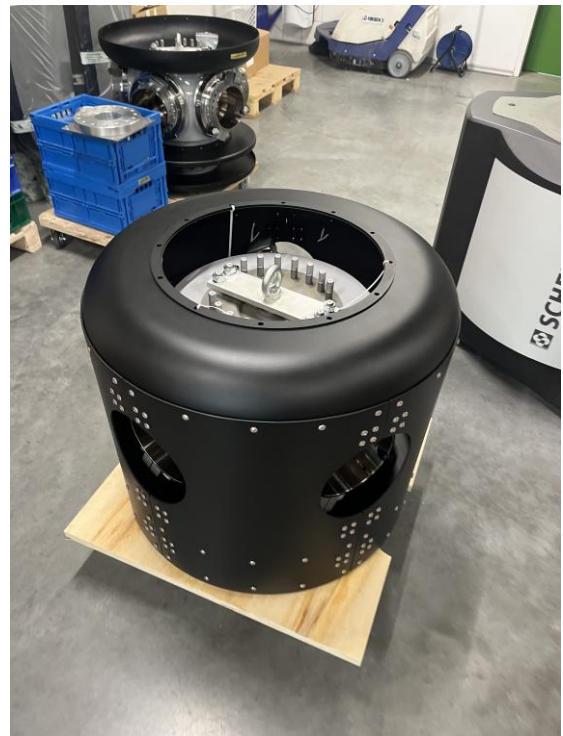
The spinner dome is a five-piece part made from fiber reinforced composite. The pieces are assembled by stabilization plates and screws.

Spinner rear support plate and the mid-support-plate are parts of the hub. The spinner front support (dome) is mounted to the drive shaft adapter. The dome is mounted on the supports by means of screws.

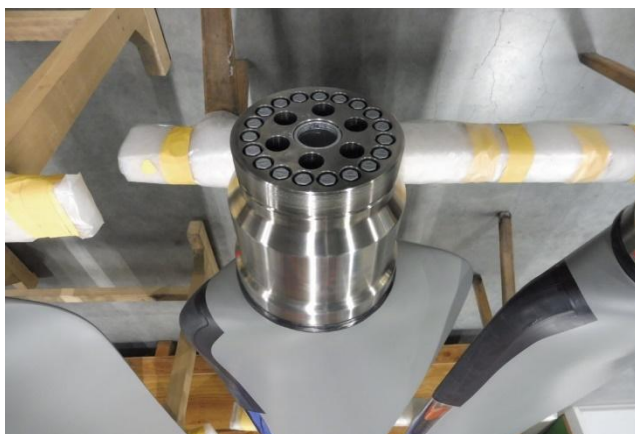
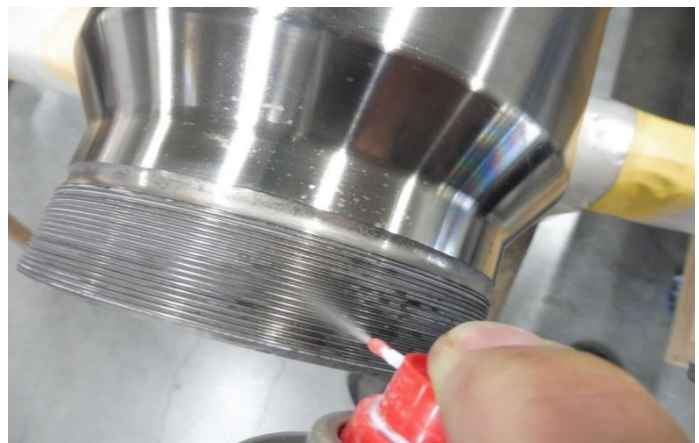
**Figure 4 / 4a: Lubricate the thread on the blade ferrule only with PTFE dry lubrication**

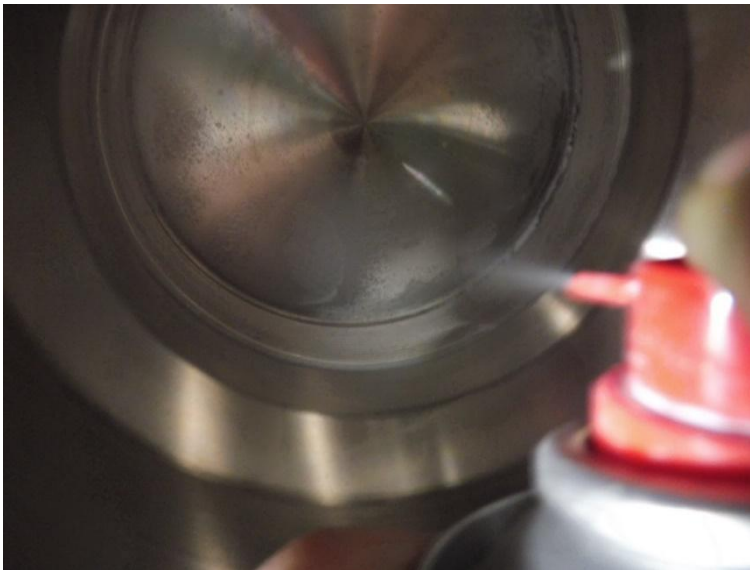
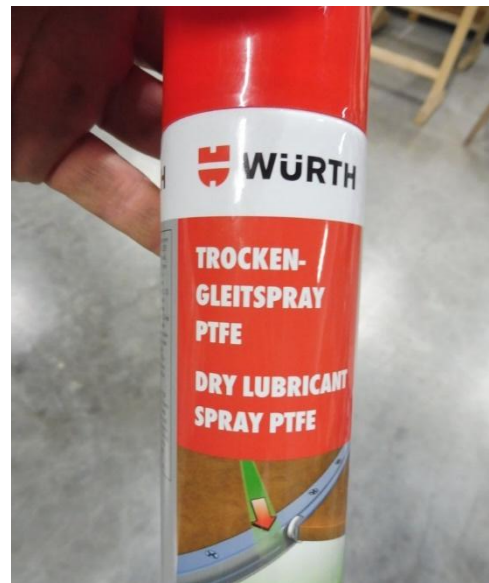
Figure 5: Lubricate inner thread with PTFE dry lubrication spray

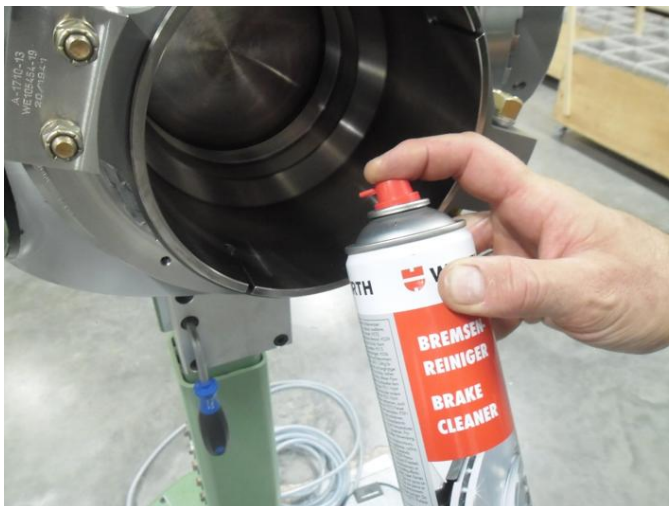
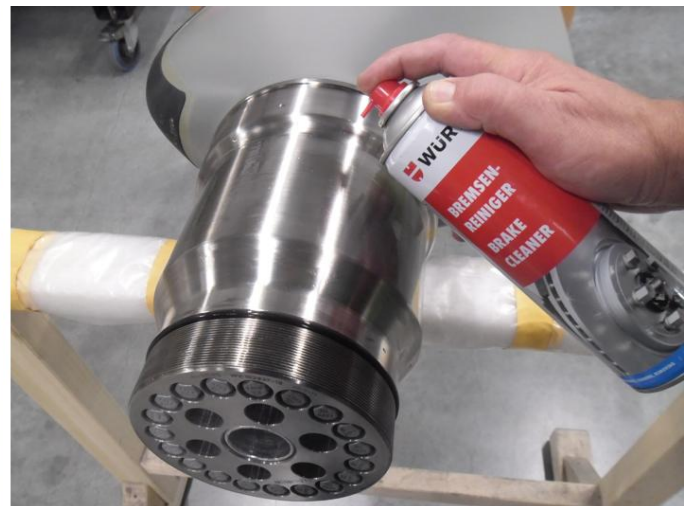
Figure 6: Cleaned and degreased surfaces, used for clamping for the friction to fix the inner blade in the outer blade ferrule

see Figure 6 and Figure 7. Check that there are no damages on the threads of the ferrules.

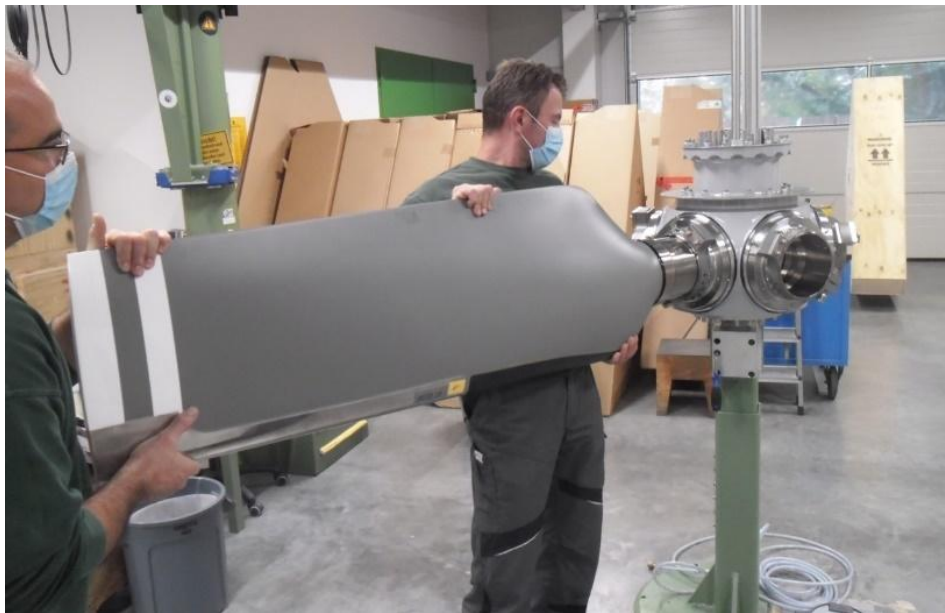
**Use great care** when screwing the blade with its inner ferrule into the outer ferrule and **do not use force**. In case you encounter resistance during the screwing motion **do not try to force the inner ferrule into the outer ferrule**. Screw the blade out again, check the tread for possible damage and clean the thread; then retry.

**Figure 8: Installation of the blade only with two mechanics**

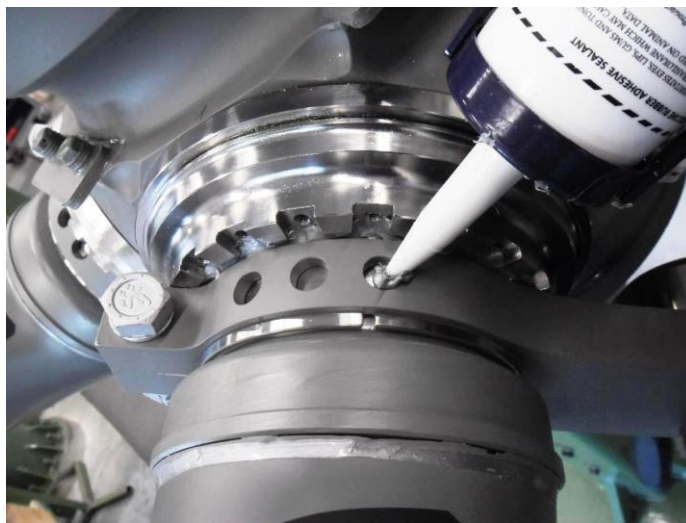
Optionally seal the pin positions which are not used with silicone RTV 109 or similar according to Figure 9 to prevent dirt intrusion.

**Figure 9: Seal the unused bores with silicone RTV 109**

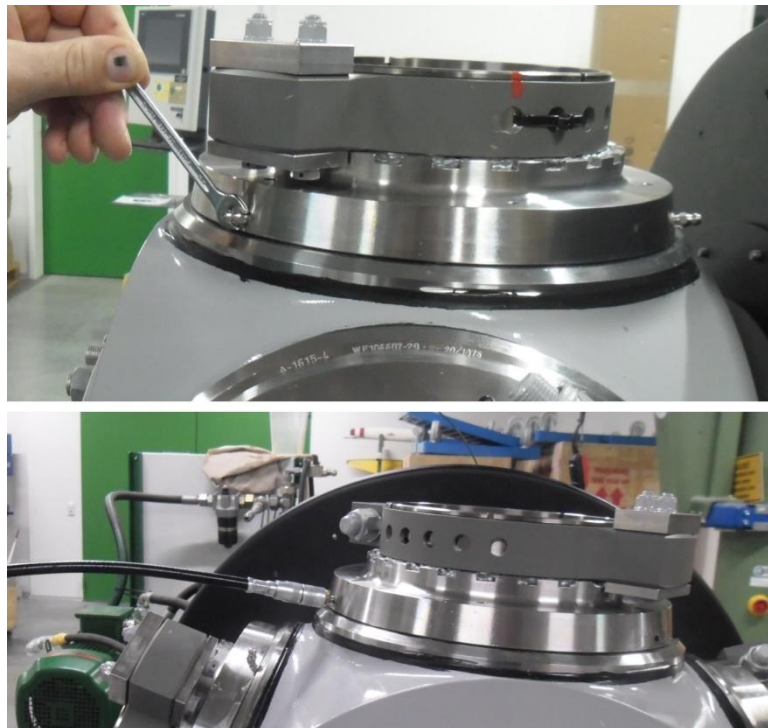
Pump MT2 - Propeller grease into the 2 remaining grease fittings until fresh yellow grease is leaking out from the void where the grease fitting has been removed, see Figure 14.

**Figure 14: Removal of one grease fitting and application of grease**

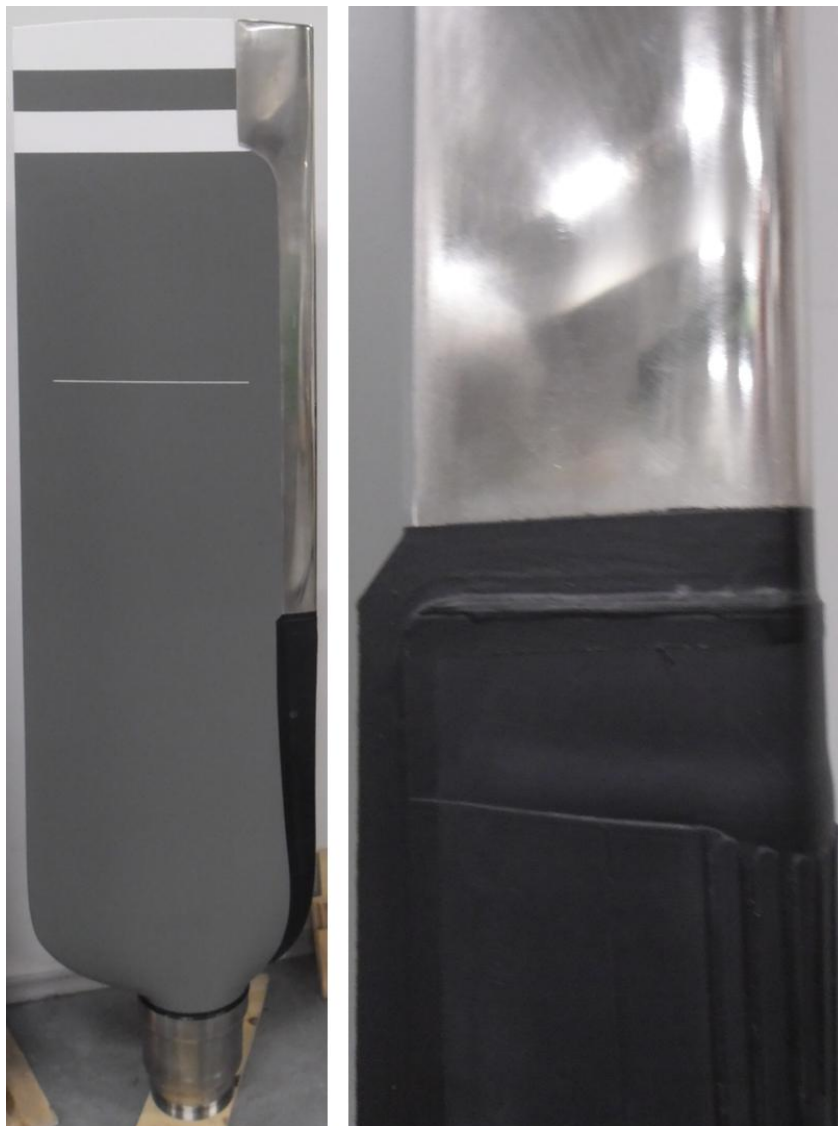
The CRRD358-160 blades are covered with boots on the blade root before the nickel erosion protection sheath.

**Figure 19: Blade with boots in root area**

The installation procedure of the boots is described in the E-1290 manual, section boots.

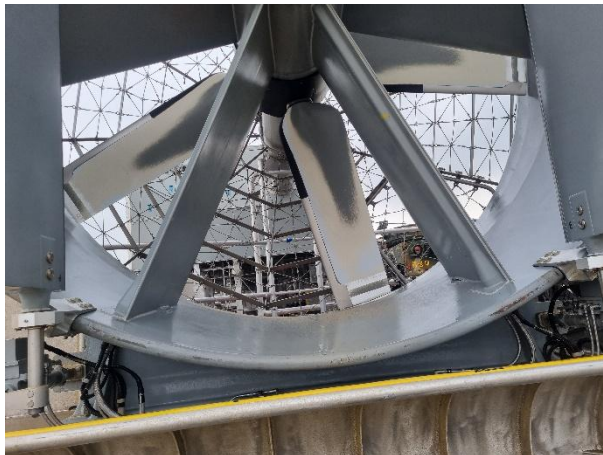
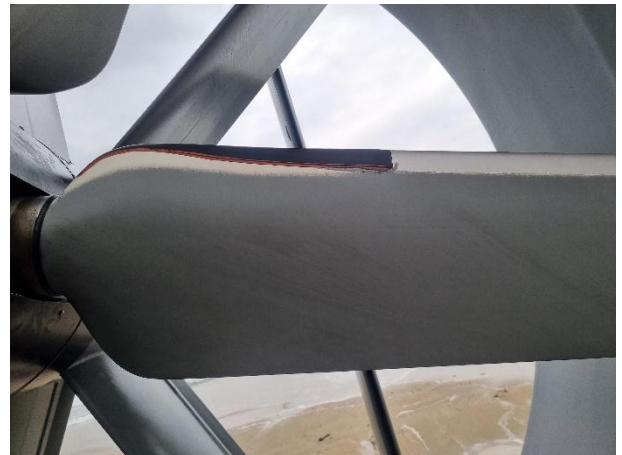
After high erosion operation paint on blade surface might be eroded on certain areas:

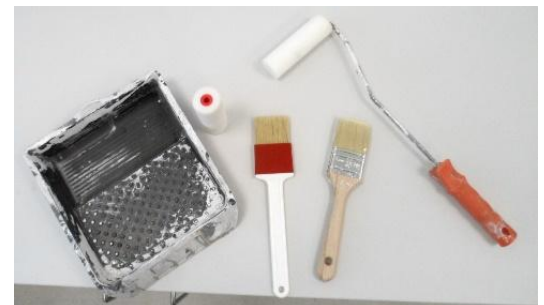
- Polane T F63TXA00128 or similar Polyurethane or Epoxy based paint
- Coloradol, MEK (Methyl Ethyl Ketone) or Acetone
- Paint brush or similar (Please make sure to use a high-quality brush with a width of 5 cm or broader, which does not lose bristles.)
- Classic paint roller (Moltoprene / PU-foam roller or similar)

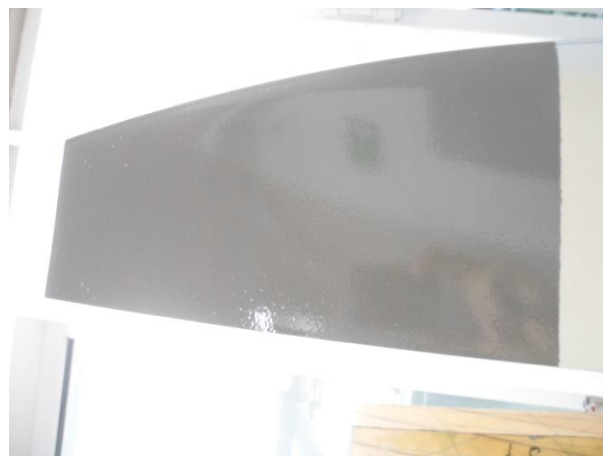
1. Mix the paint WITHOUT thinner
2. Wait 30 minutes for optimum consistency
3. Degrease blade surface with Coloradol, MEK or Acetone
4. Apply first coat of paint with a brush
5. Let dry the first coat of paint until it gets slightly sticky
6. Apply second coat of paint with a roller ("wet-in-wet")
7. Let dry according to paint manufacturer's instructions
